Hydrogen Incident December 2010

“To Learn and Share”

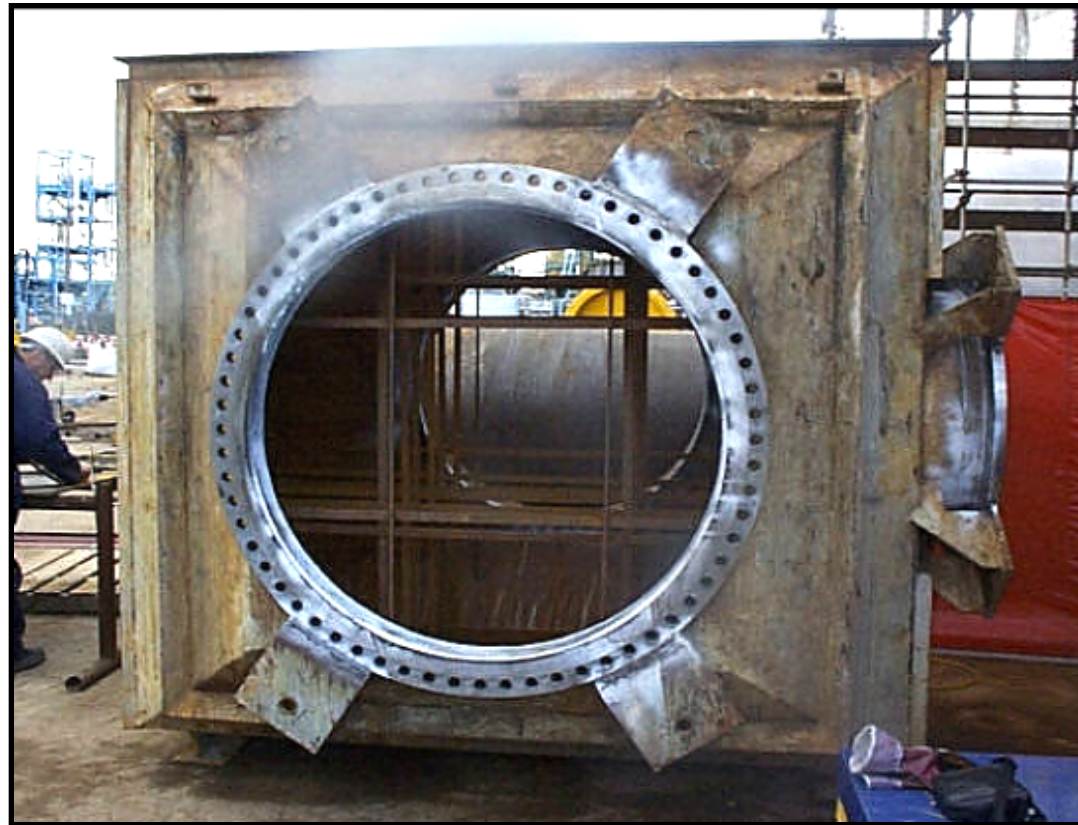
Secondary Economiser Shell - Before

- ▶ What the old vessel shell used to look like minus the HE elements

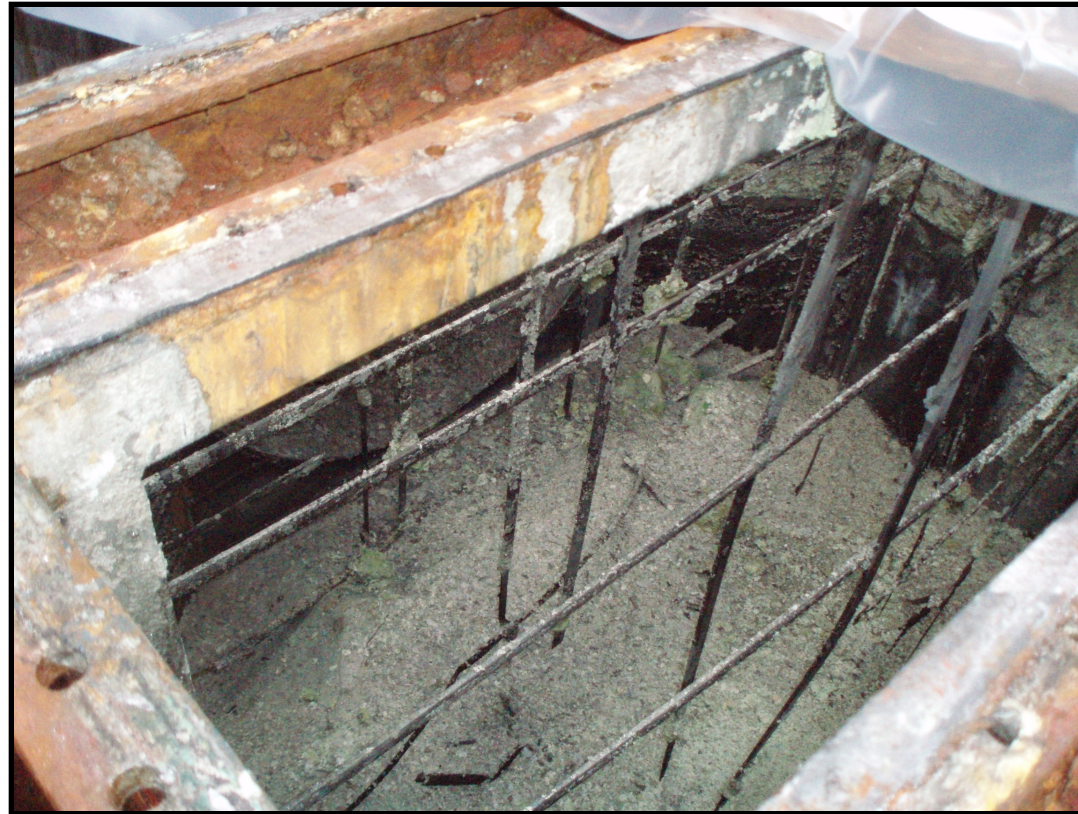
The Aftermath - Inside of the Secondary Economiser

- ▶ Resultant state of secondary economiser, vast corrosion of steel

- ▶ Sequence of outages led to repeated condensation in the secondary economiser.
 - ▶ The removal of the gas drain in 1996 meant that this vessel shell was not drained of that liquor.
 - ▶ The liquor pool corroded the base of the U-tubes
 - ▶ Massive water ingress caused rapid further acidic corrosion, liberating significant hydrogen which filled the system while the plant was SD.
 - ▶ Plant gas paths were stagnant because the plant was stopped.
 - ▶ Hydrogen migrated by buoyancy and gathered in the top section of the inter pass tower.
 - ▶ The hydrogen in the top of the inter-pass tower was ignited (static) and caused the confined explosion.
-

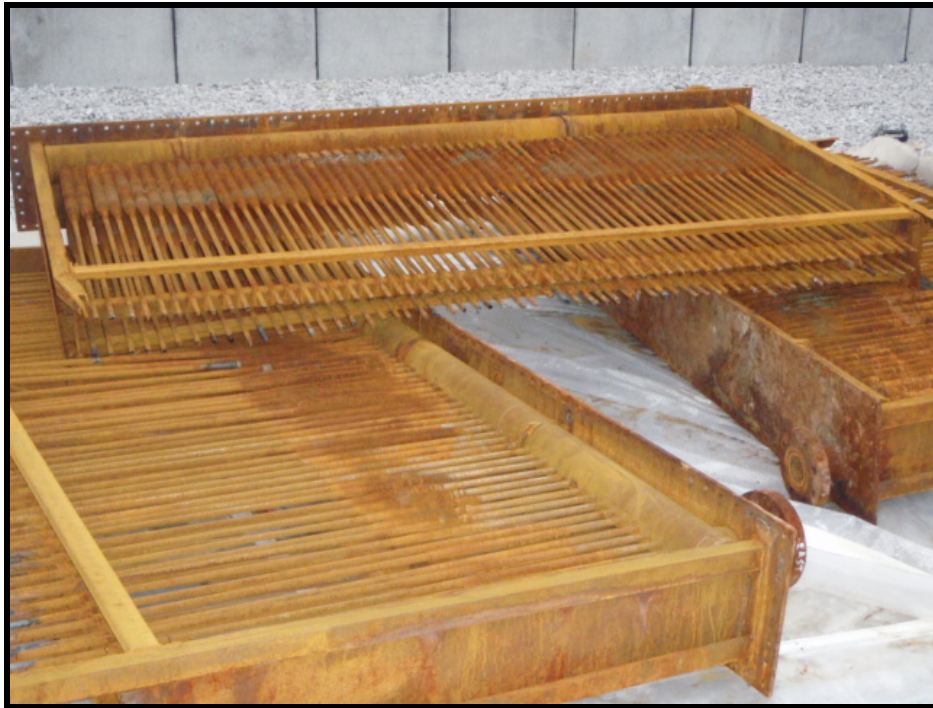
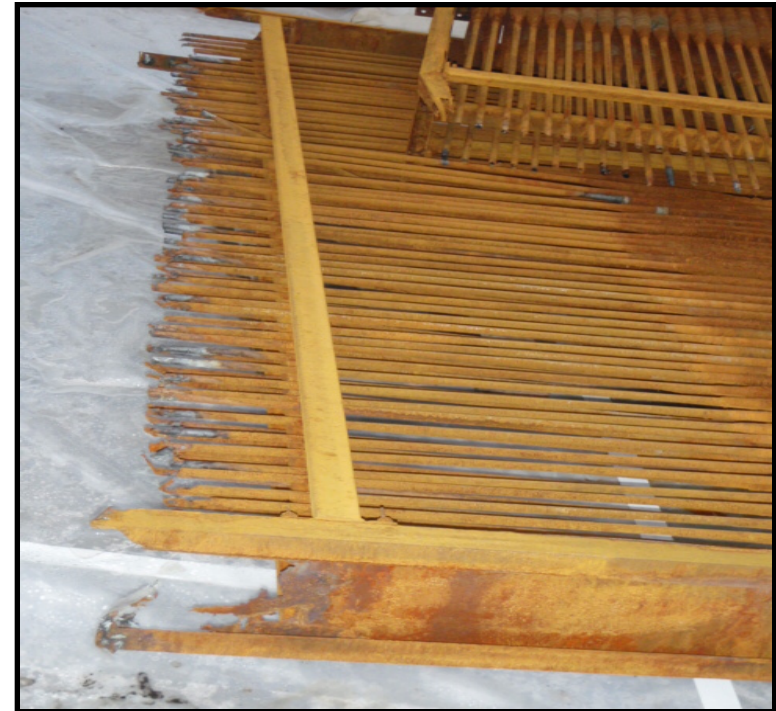
The Aftermath - Secondary Economiser Bundles

- ▶ Resultant condition of tube bundles – Lost approx 1 metre from all three bundles

- ▶ We rolled the dice....we didn't know what we didn't know.
- ▶ The secondary economiser had been installed in 1984 for energy/absorption efficiency, complete with drain.
- ▶ Drain removed from it in 1996, reason unknown.
- ▶ December 2010 - tube bundle(s) failed - resulting in weak acid being produced in the gas side of the unit
- ▶ Lead to rapid corrosion of tube bundles in vessel and large scale strength control excursion in towers/circs/coolers.
- ▶ Corrosion generated significant quantities of hydrogen, which collected at the top of the inter-absorber, one of the high points of the plant.
- ▶ The hydrogen, which has low activation energy, caused pressure excursion when it found source of ignition.

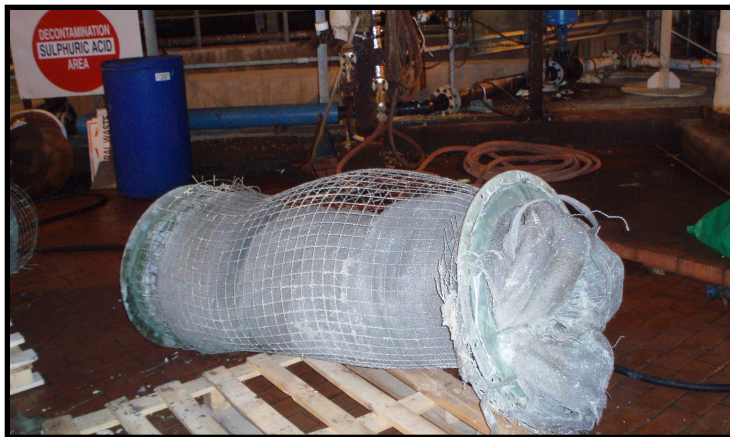
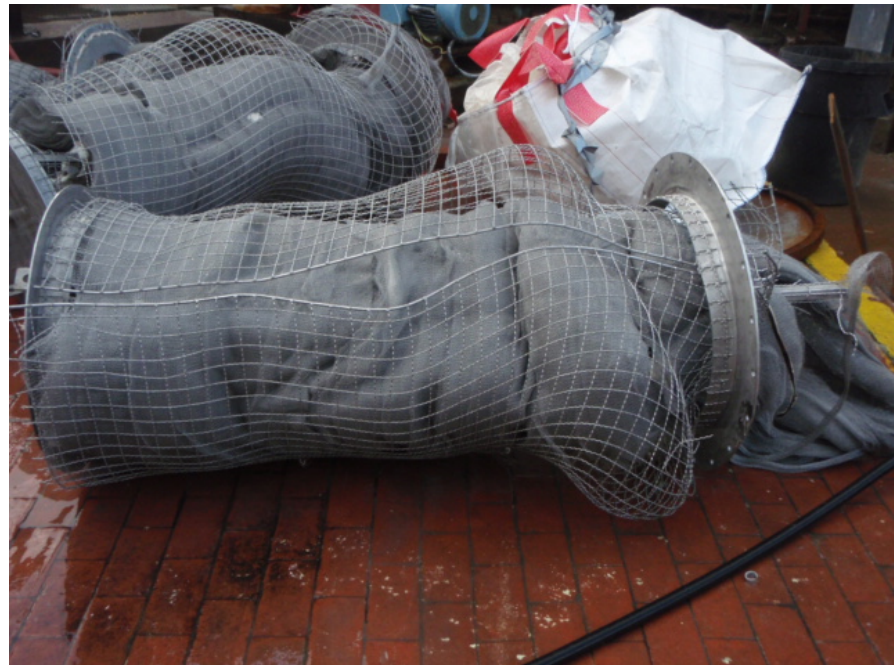
What happened?

- ▶ The pressure generated resulted in damage (deformation, bulging and cracks) to the top of inter-absorber tower and destruction of the candle filters in the tower
