Hydrogen Safety In the Sulphuric Acid Industry

7-10 November 2011, Houston, Texas

SULPHUR 2011

Hydrogen Safety Concerns In the Sulphuric Acid Industry

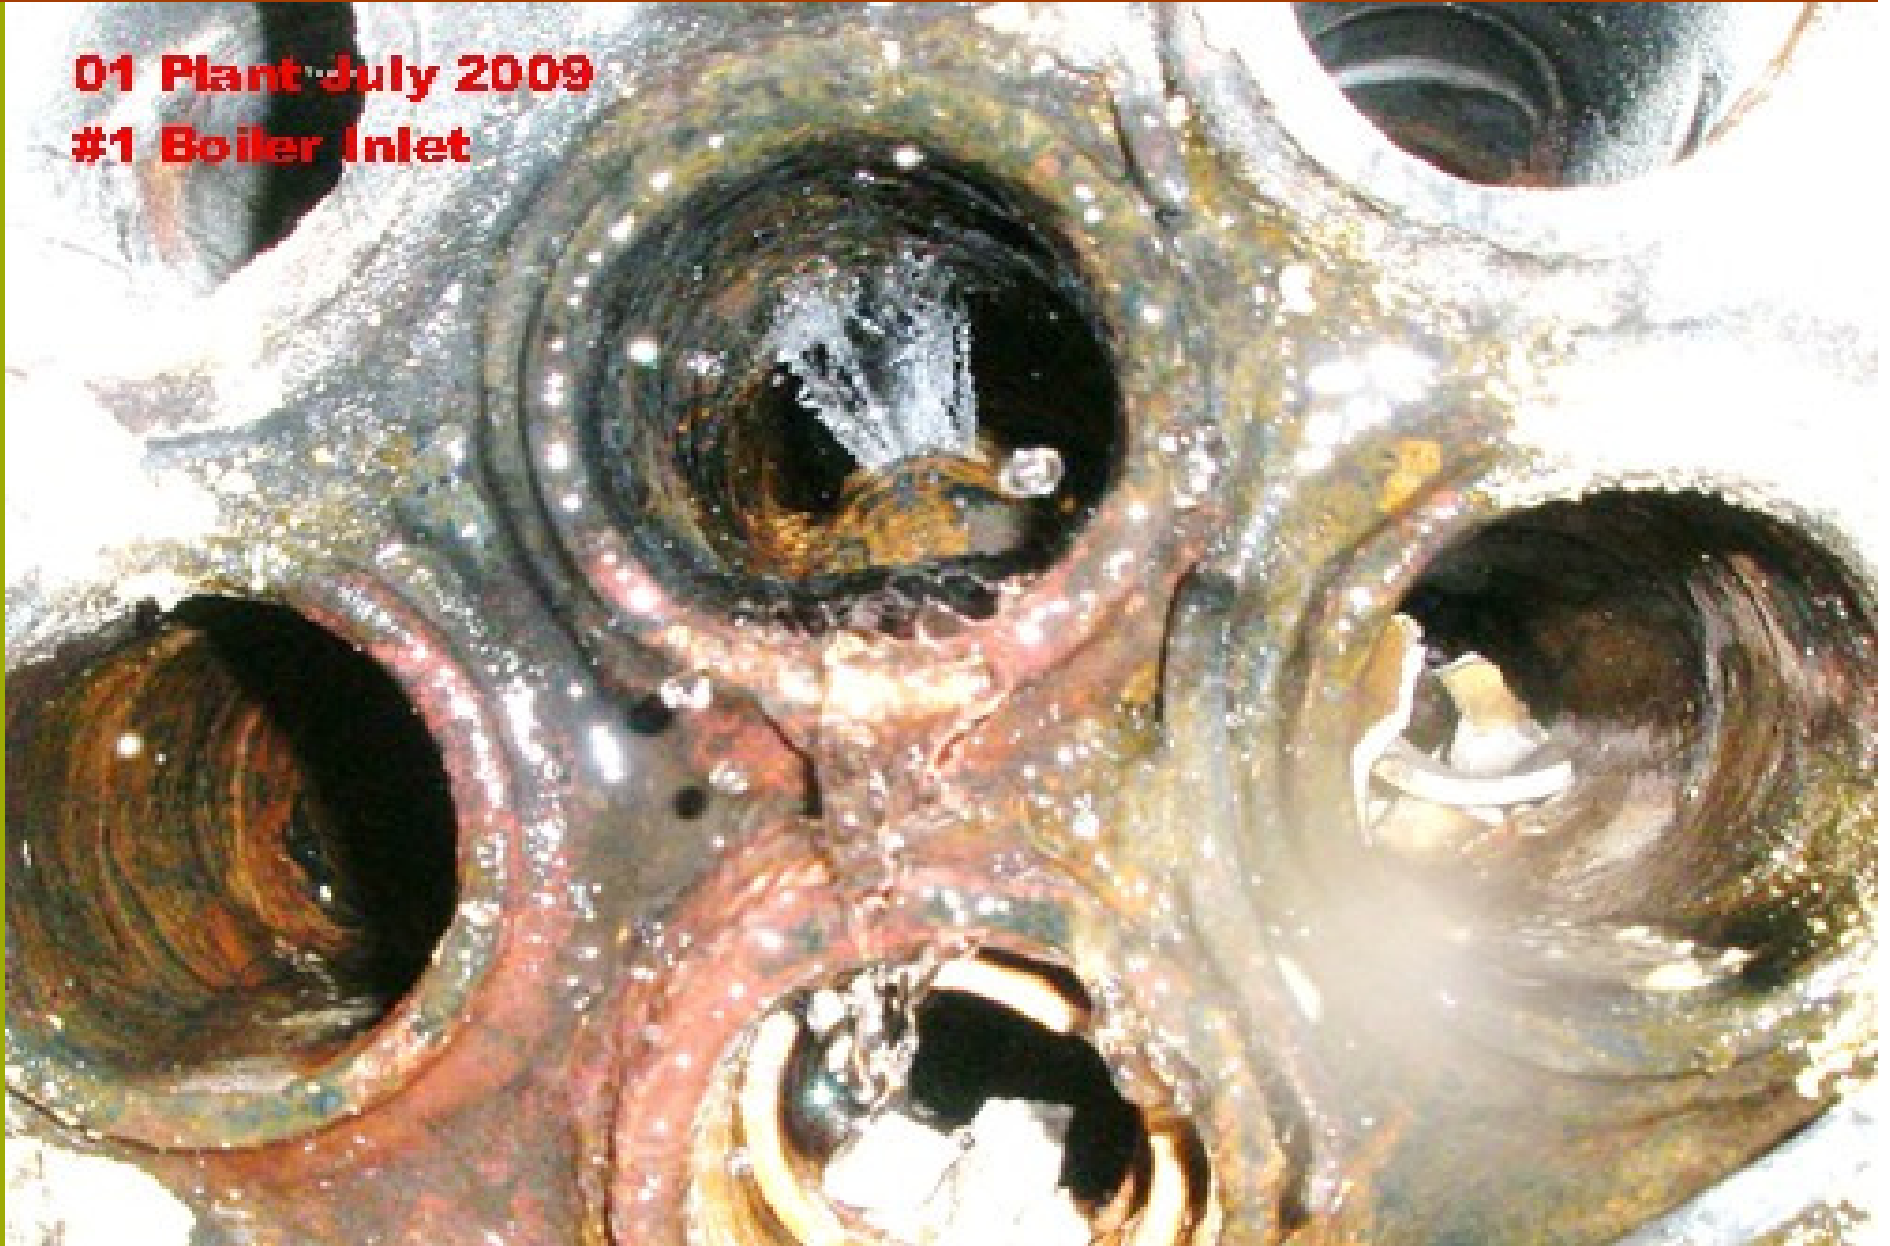
#1 Boiler Inlet

First Hydrogen Event - Waste Heat Boiler Leak

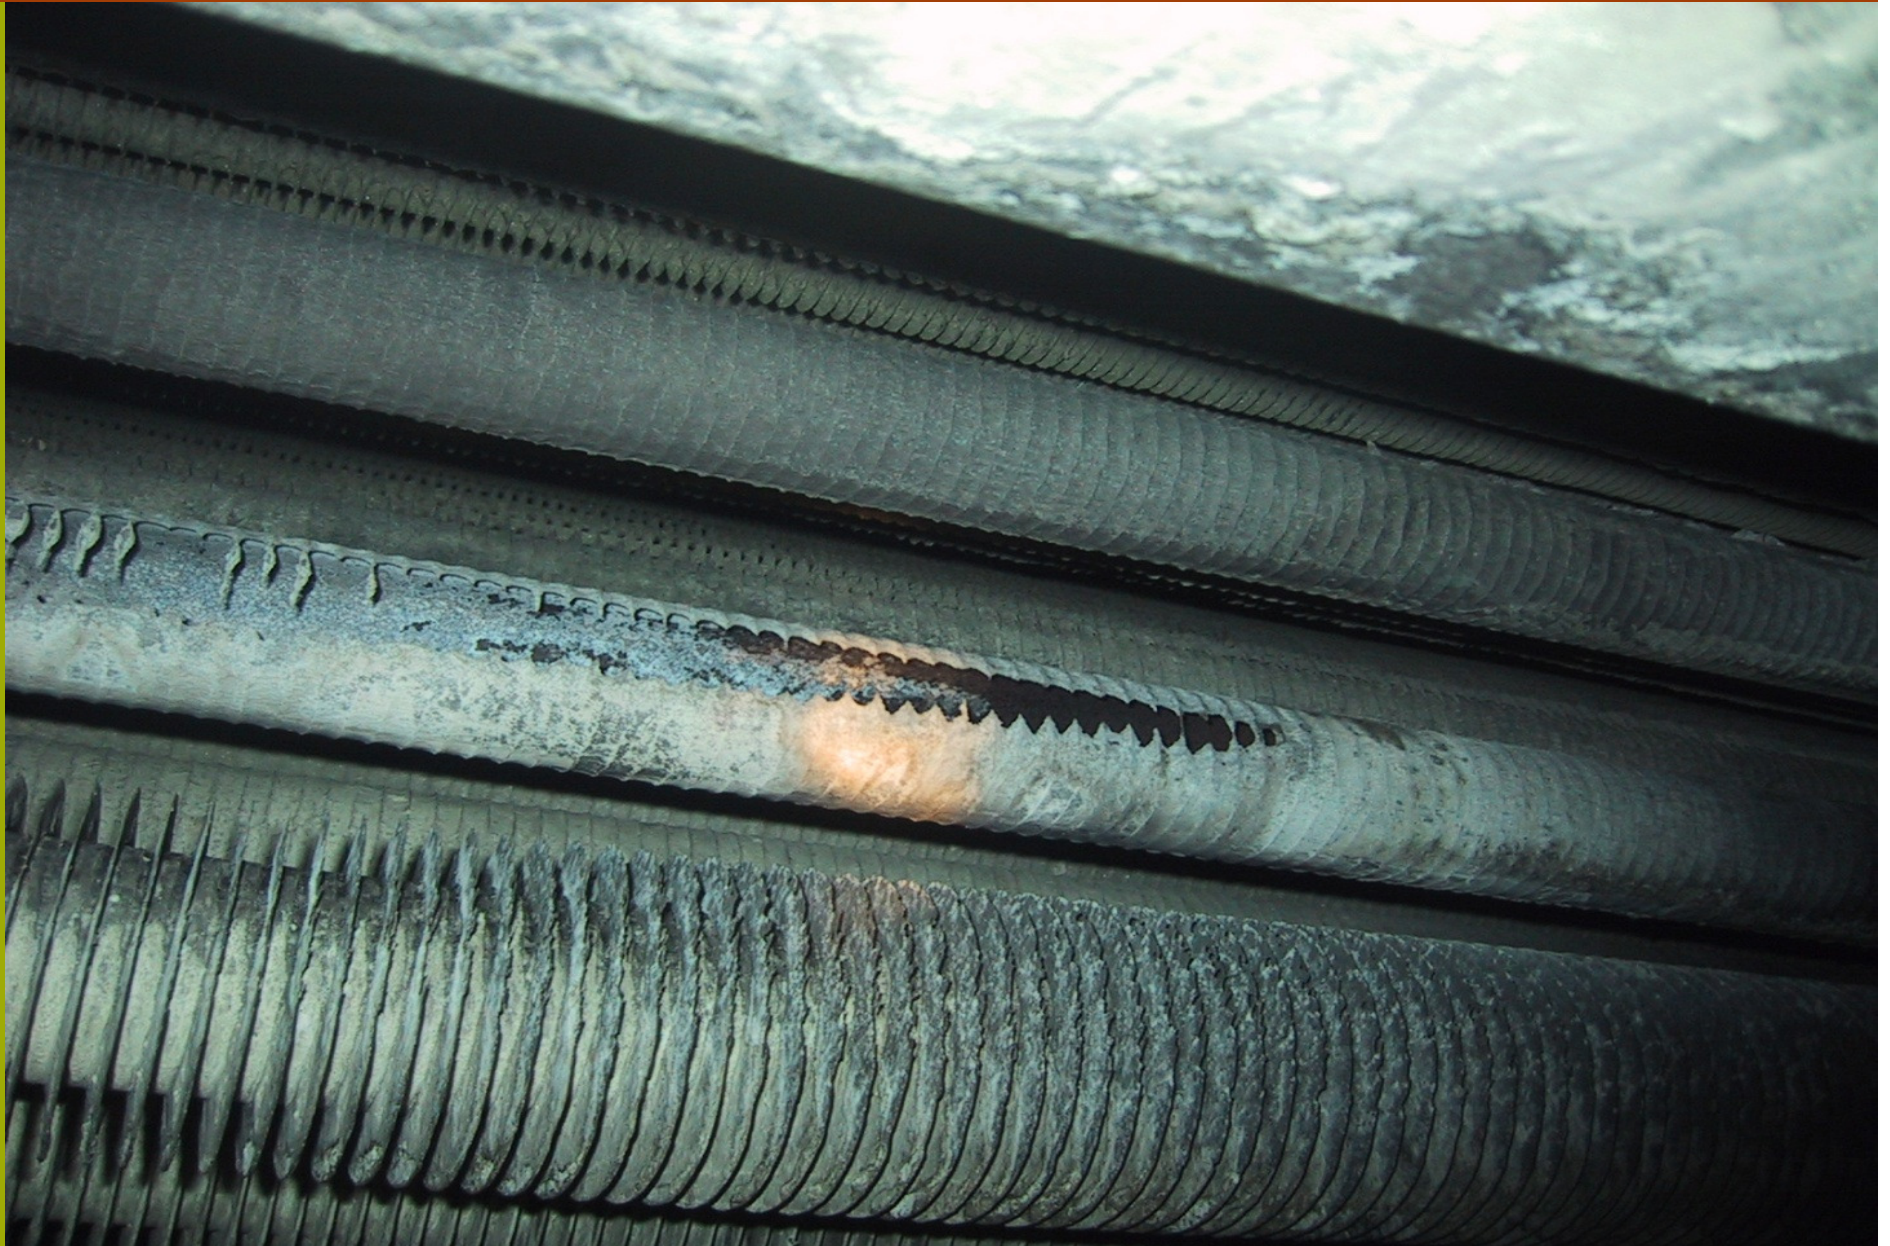
First Event / Secondary Failure – Economizer Tube

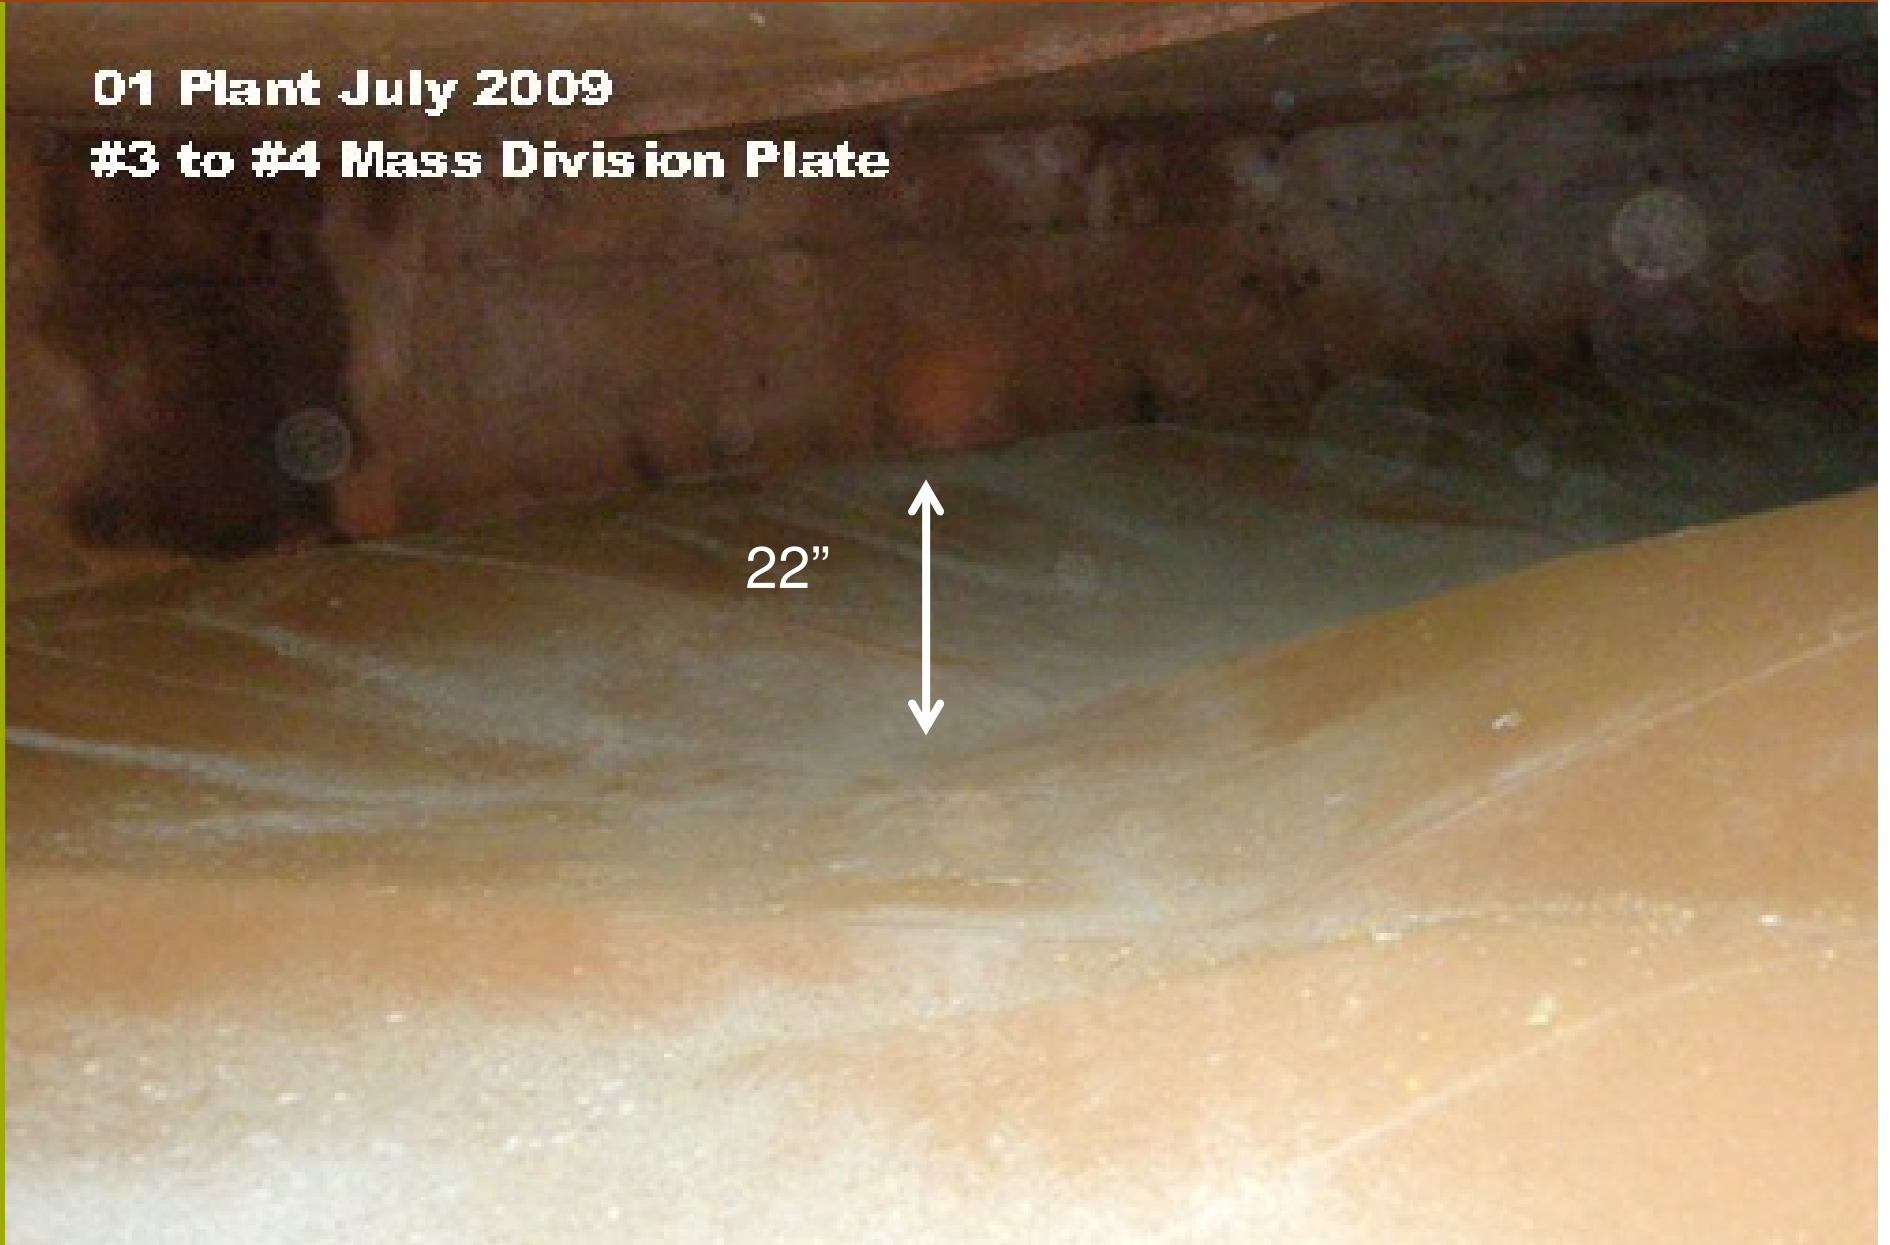
#3 to #4 Mass Division Plate

First Failure – Radial Flow Converter Damage

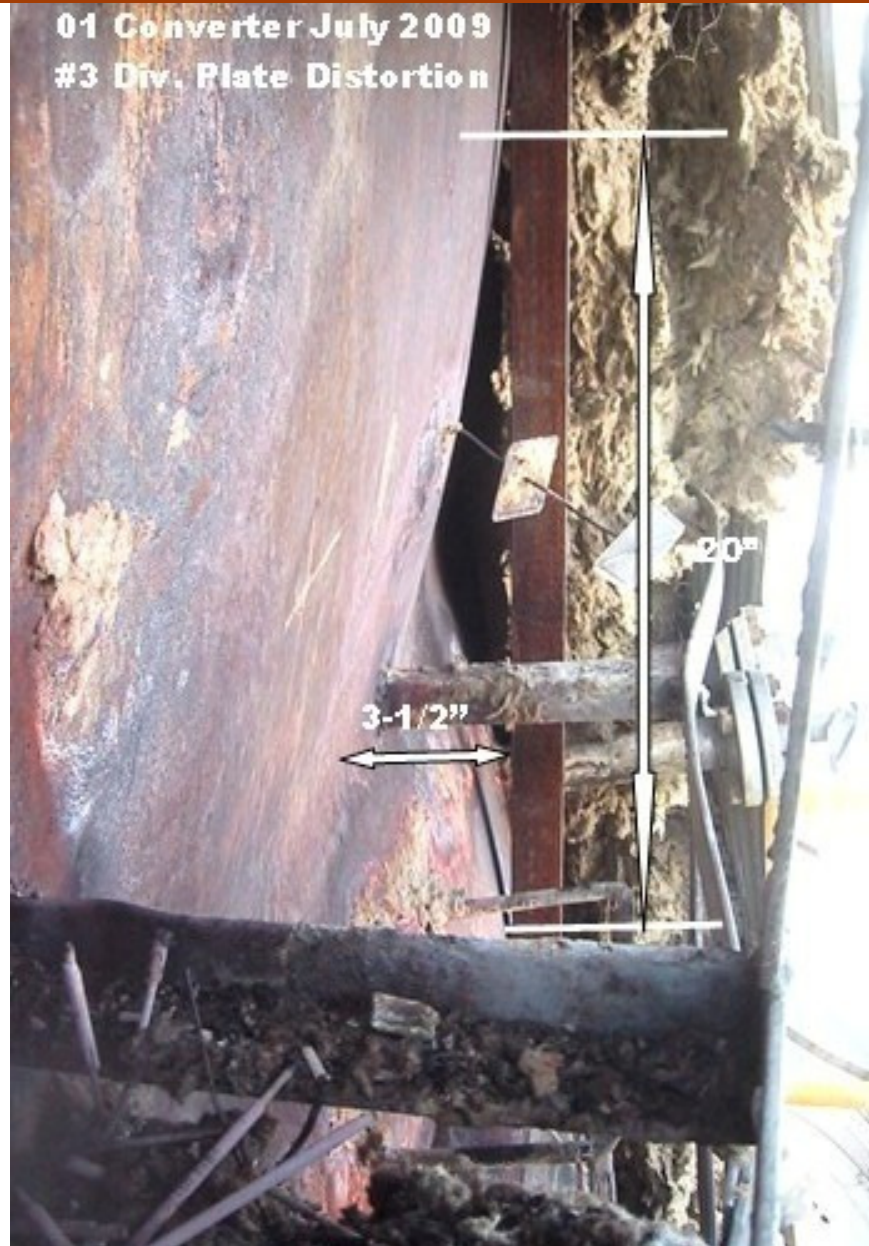
01 Plant July 2009
#3 to #4 Mass Division Plate

First Failure – Converter Damage

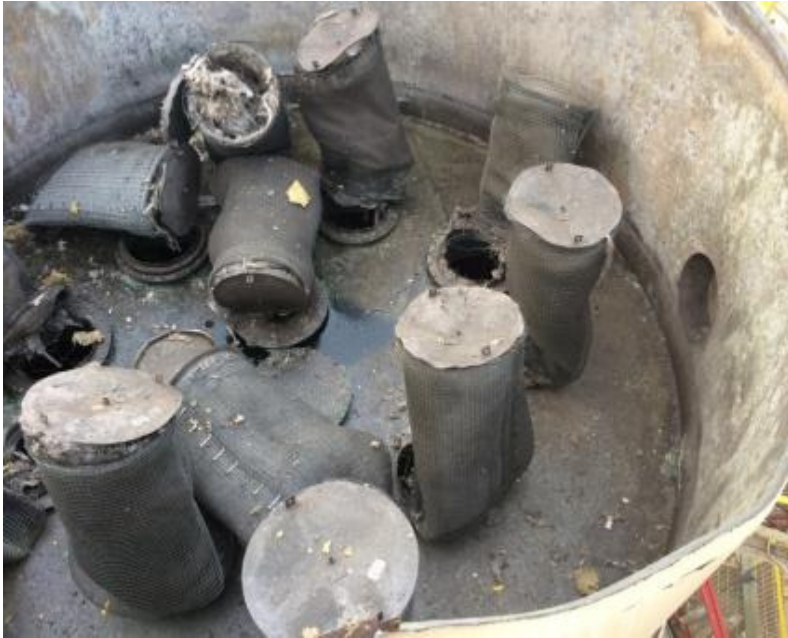
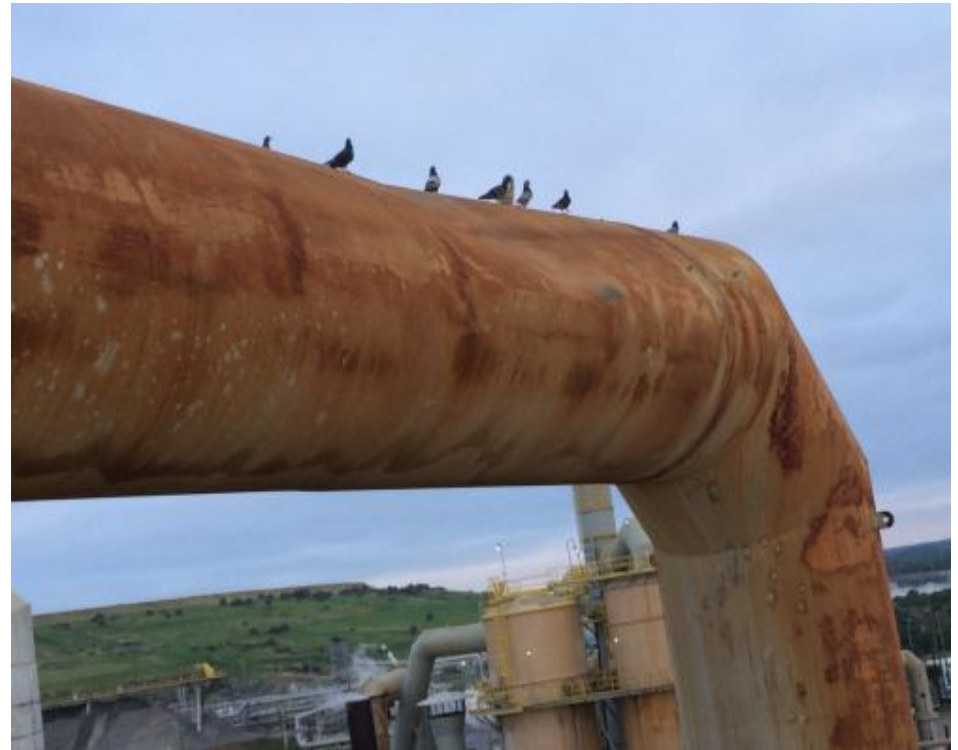
Left Picture: shows damage to the candle level of the IPA Tower

Right Picture: shows damage to the DT Exit Duct as the roof of the IPA Tower made contact with it

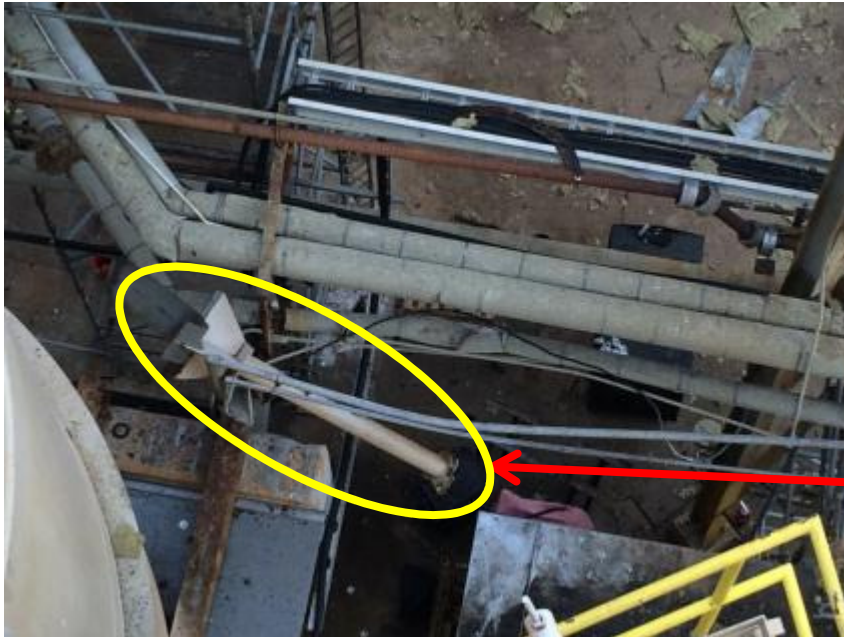
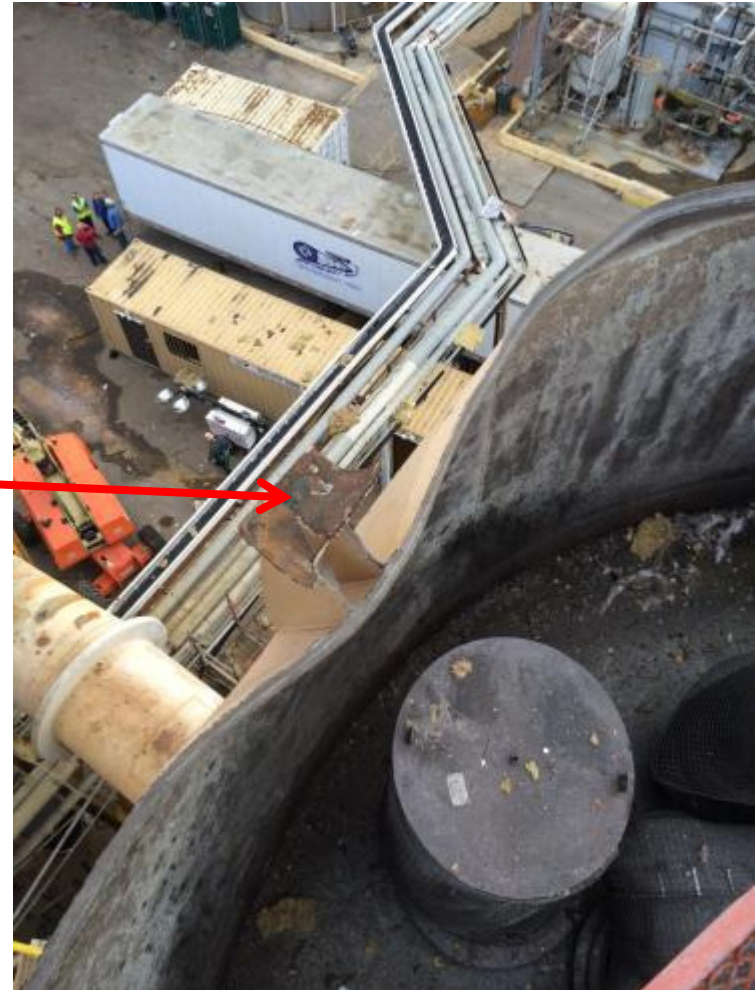
These two pictures show the IPA Exit Duct Support; where it used to be, where it wound up

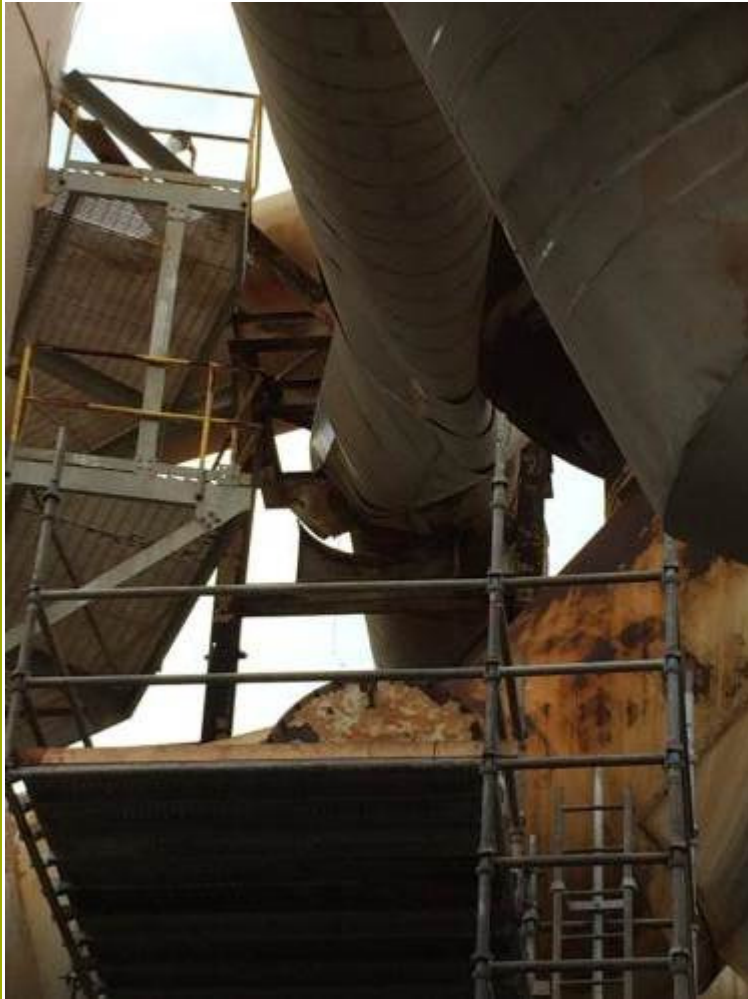
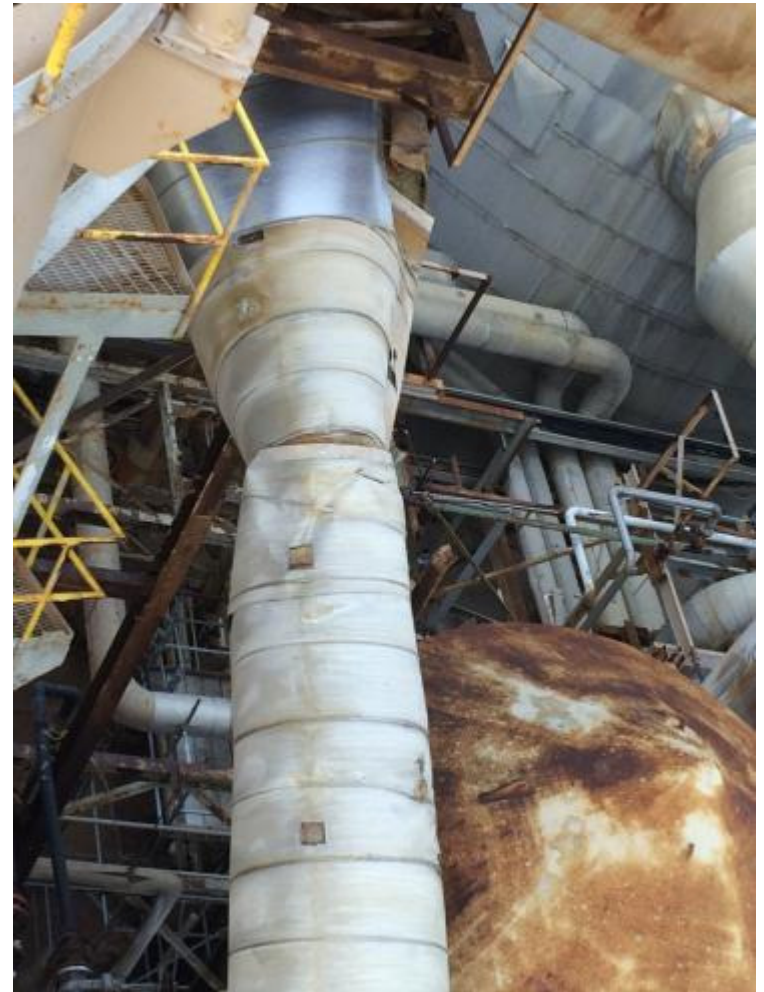
This is two pictures of the same section of duct. One from above and one from below

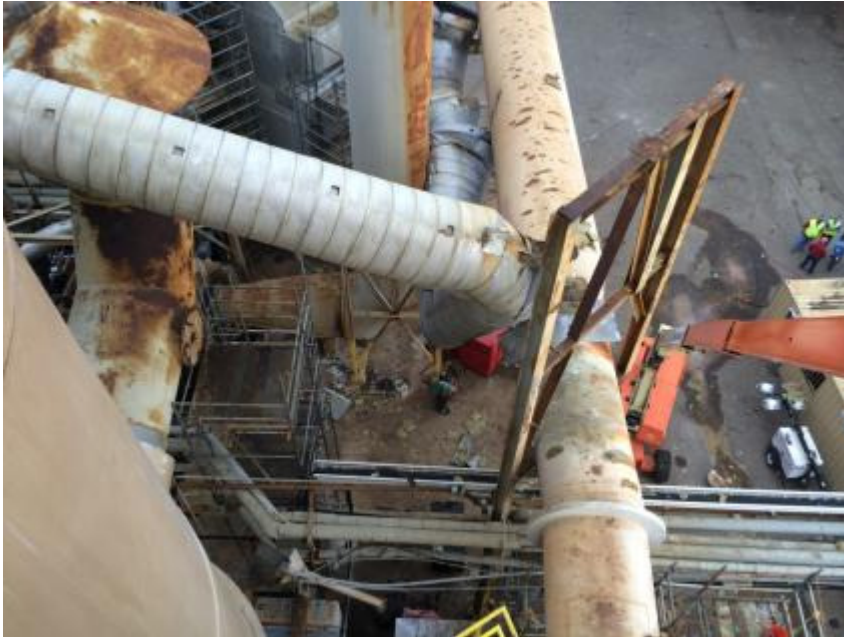
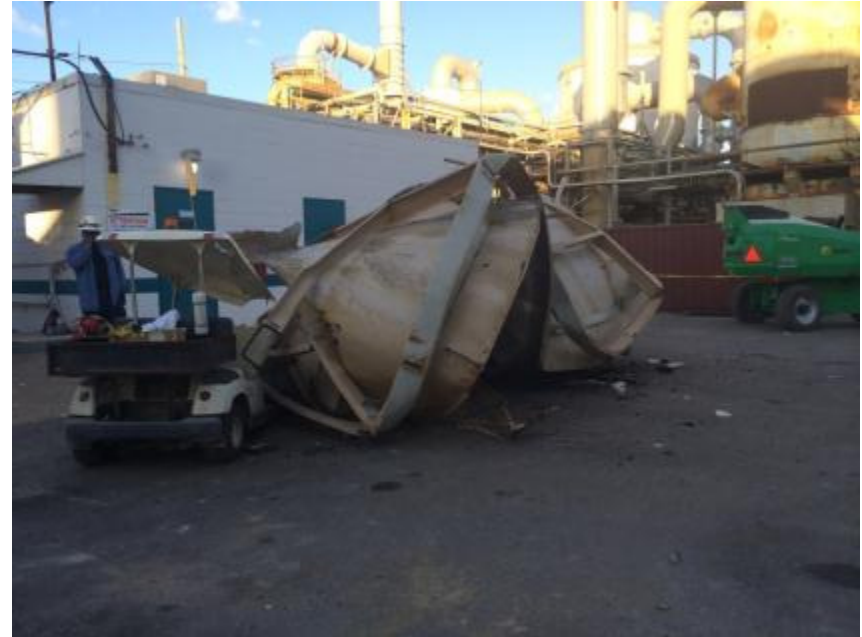
Left Picture shows how the duct rotated 180 degrees from South to North
Right Picture shows the roof of the IPA Tower where it landed

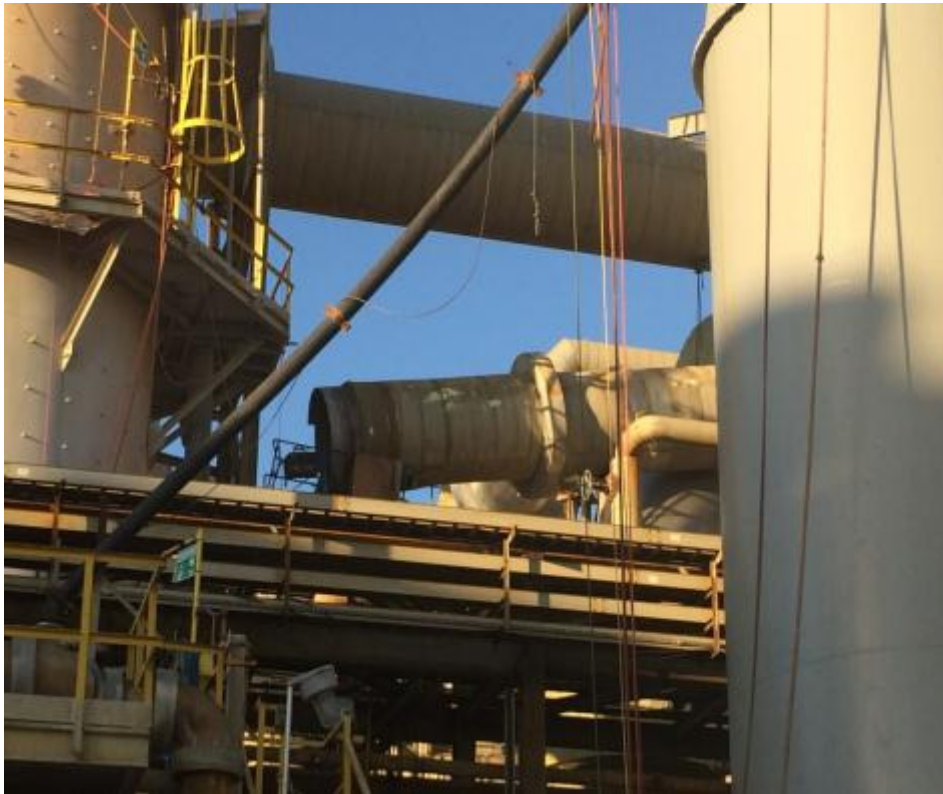
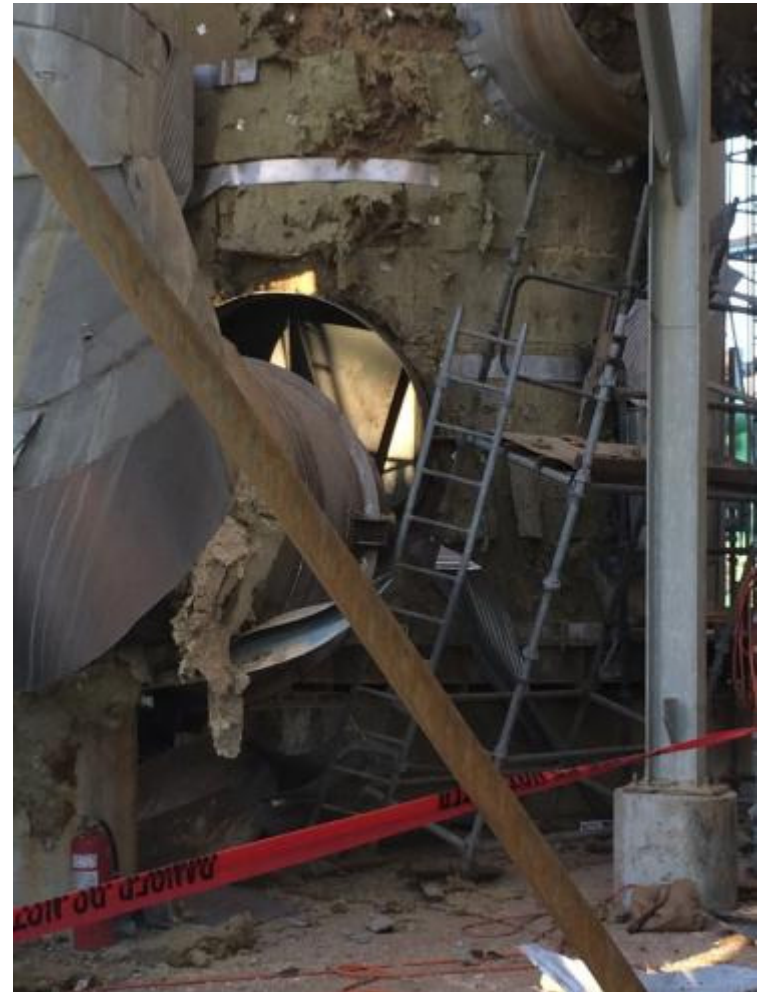
Left Picture shows where the contractor was actively welding the band on the duct
Right picture shows the force of the blast blowing the flashing off the Cold Hex

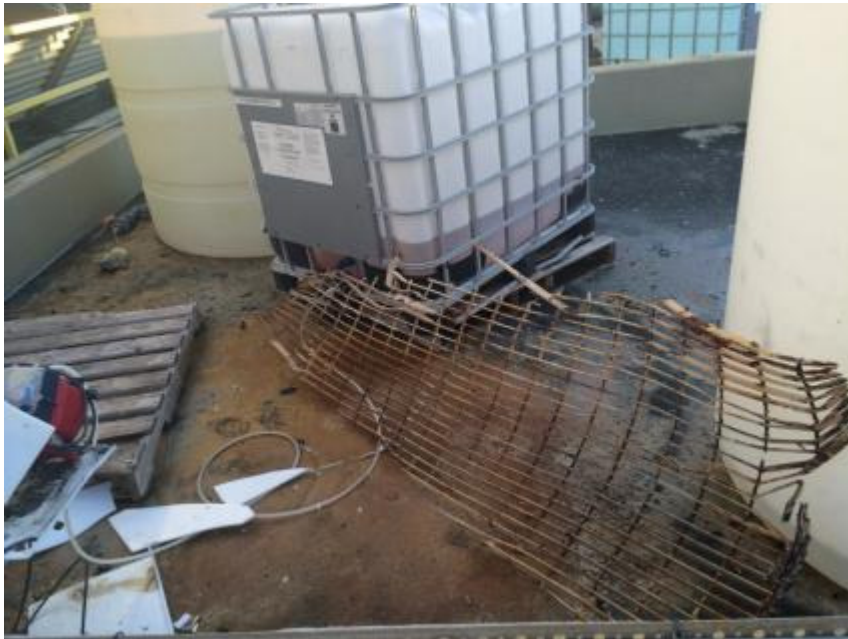
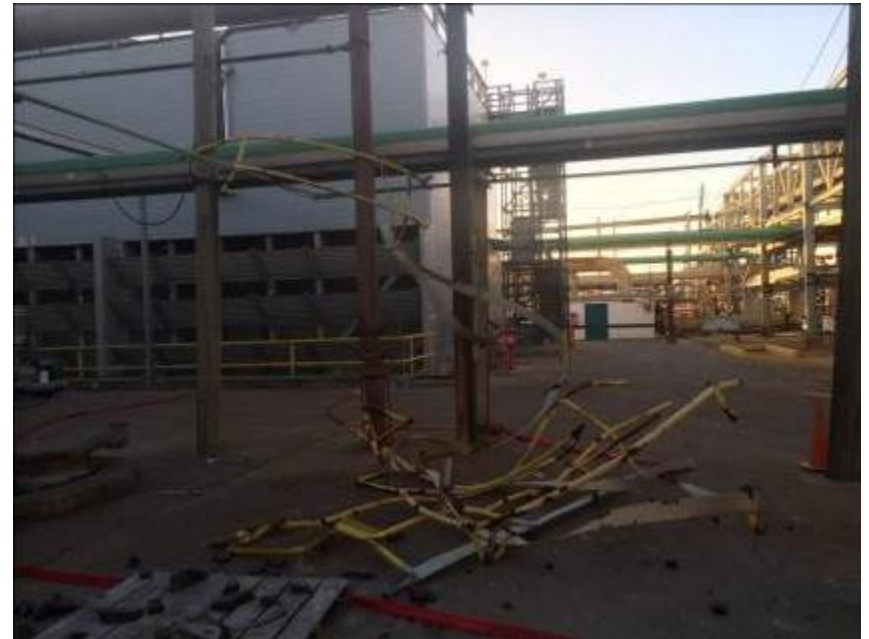
Misc. debris in the blast radius

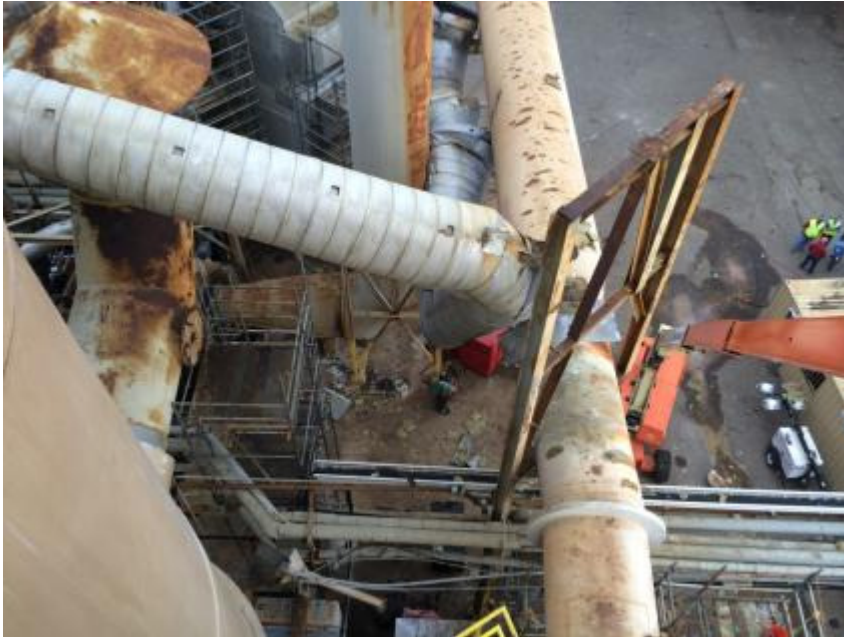
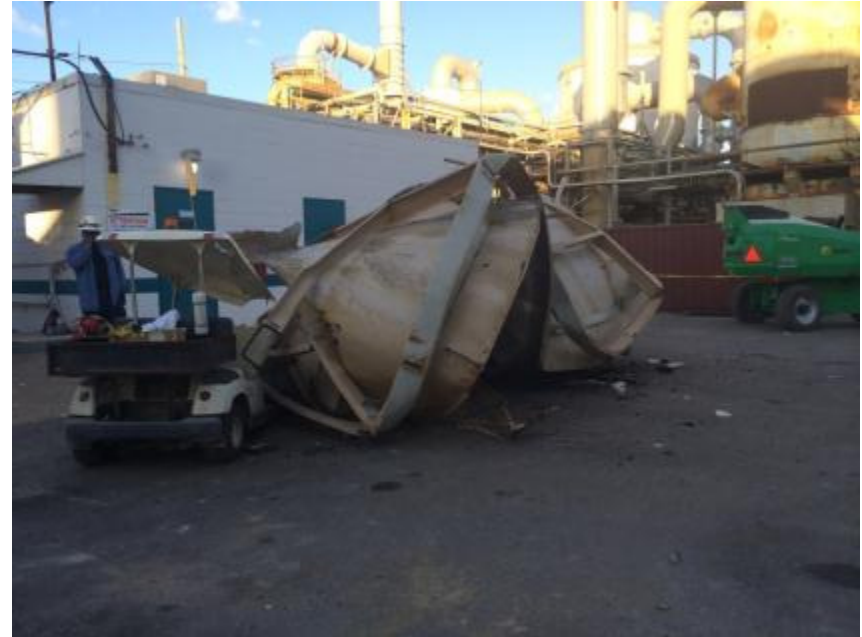
Left Picture shows how the duct rotated 180 degrees from South to North
Right Picture shows the roof of the IPA Tower where it landed

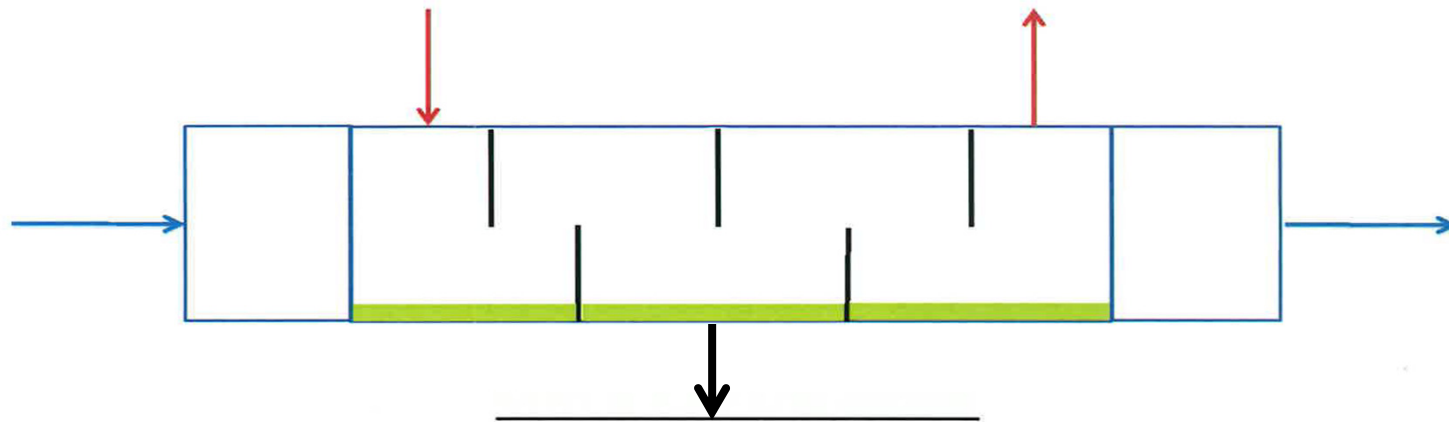
Residual Sulfates Plugged off Baffle Drain Notches

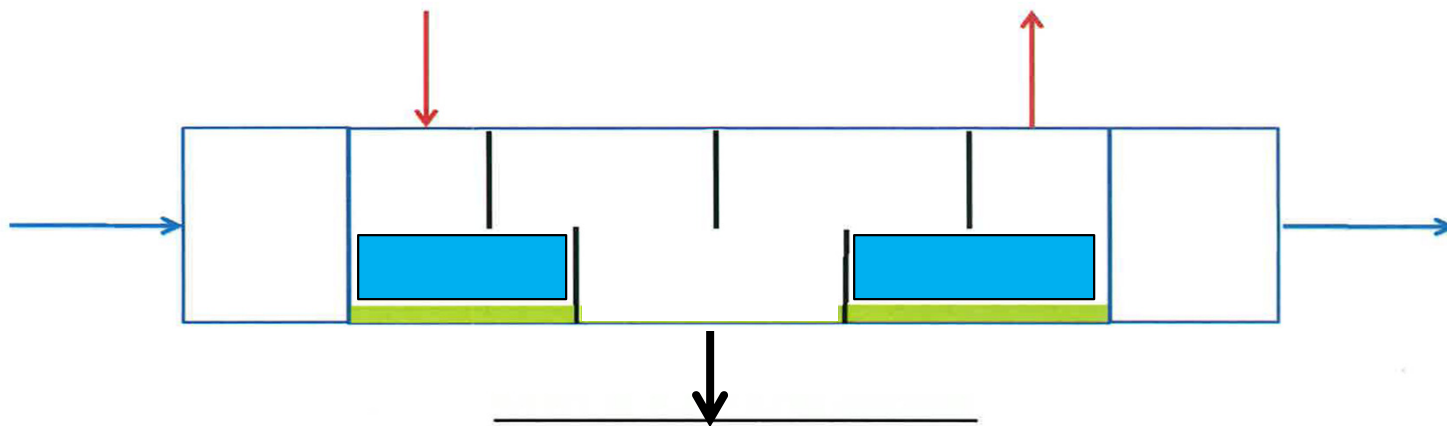
- Acid Side only has one drain in center - drain check indicates cooler is empty
- Neutralizing solution is trapped behind baffles
