# Case histories from the sulfuric acid industry

By: Orlando Perez, OP & Associates – H<sub>2</sub>SO<sub>4</sub> Consultants

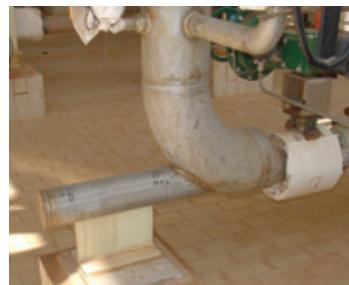
One of the cost-effective methods used by piping designers to support pipelines is to weld a dummy pipe on elbows to provide vertical or horizontal support, as shown in Fig. 1.

Fig. 1: Dummy pipe support on elbow.

Never support acid pipelines with dummy pipes on elbows. While this method may be acceptable for non-corrosive/erosive fluids, it is not good practice for acid pipelines. The dummy pipe prevents regular ultrasonic thickness inspections from detecting thinning of the elbows' critical areas.

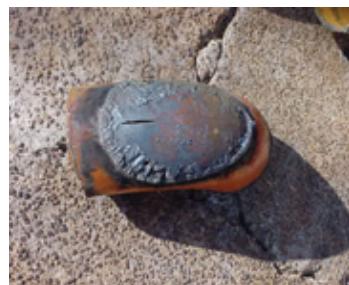
This method was used in a carbon steel acid pipeline to transport 99.2 percent acid to a refinery customer's storage tank located a couple of miles from the acid plant. The pipeline is supported on pipe racks together with other pipelines that run along the roadway. A routine pipeline inspection revealed a leak that was emanating from one of the dummy pipes that was welded to elbows. The pipeline was evacuated to perform a closer inspection and repairs. Removal of the dummy pipe revealed a slit on the elbow, as shown in Fig. 2. The elbow had suffered erosion-corrosion from acid flow, as shown in Fig. 3.

Fig. 2: Slit on elbow. Note the dummy pipe support outline on elbow.

Consider the effective flow area in elbows when sizing

pipelines; acid velocity guideline in open literature is only for straight pipes.

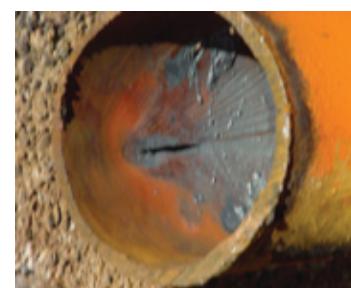
Fig. 3: Erosion-corrosion on elbow.

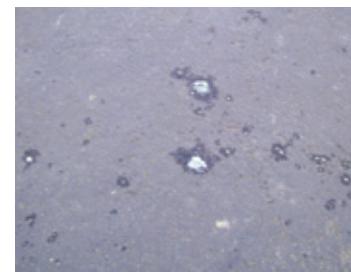
Fig. 4: Sulfate on asphalt roadway coming from the stack.

process safety review, as part of the management of change (MOC), was never performed. During the course of plant operation after the vent line removal, sulfate started to appear on roadways in the vicinity of the stack. The stack had been spitting! Investigation revealed that the vent nozzle in the stack for the decommissioned equipment was

never blinded off when the vent line was removed. This allowed moisture to draft in, wetting the dry sulfate coating on the stack interior. When enough moisture collects, the sulfate dislodges, gets carried with the gas and spews out of the stack. The sulfate comes back down and lands on nearby equipment, building roofs and automobiles, causing damage to properties.

Always perform process safety reviews of equipment changes no matter how innocuous they may appear. Perform regular inspections, especially checking the bottom of the stack for holes that may have resulted from corrosion due to weak acid formation.

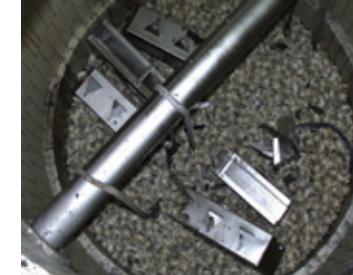
The choice of materials for the tower and its internals is critical; improper selection can lead to premature failure. Such is the case for the SO<sub>2</sub> stripper in a metallurgical acid plant. The technology provider chose an alloy material that is resistant to the acid concentration and temperature for the distributor. In less than two years, the distributor failed catastrophically, as shown in Fig. 5. Weak acid that formed on the outside surfaces of the distributor during normal

Fig. 5: Corroded SO<sub>2</sub> stripper distributor.

operation and downtimes caused corrosion of the alloy material.

Always consider the process and all the possible modes of operation for the equipment when choosing materials of construction. Materials that are resistant to the acid concentration and temperature may not necessarily work even for normal operations, let alone upsets or downtime modes.

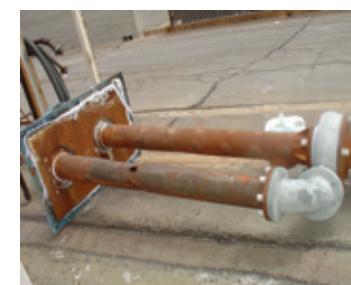
Water dilution in pump tanks has been and continues to be one of many sources of headaches to many acid plant operators. The corrosion of acid circulation pumps resulting from the failure of the water dilution system has contributed to the reduction of the plant's overall equipment efficiency (OEE). Corroded acid circulation pumps as shown in Figs. 6 and 7 will result in an unplanned plant shutdown due to an increase in stack SO<sub>2</sub>/SO<sub>3</sub> emissions. Roof corrosion, as shown in Fig. 8, is also a consequence of the water dilution system failure.

Fig. 6: Hole in pump discharge pipe. Pump shaft column is also corroded.

Never change material of construction without having full understanding of the failure mode.

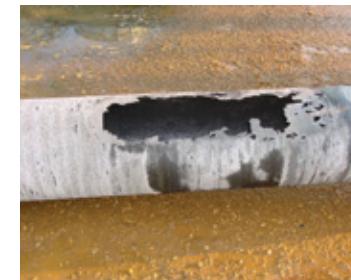
Fig. 7: Pump discharge pipe corrosion.

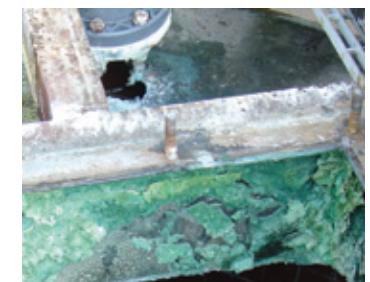
Fig. 8: Stainless steel roof nozzle and pump support beam corrosion.
