# Hydrogen Safety In the Sulphuric Acid Industry

7-10 November 2011, Houston, Texas

**SULPHUR 2011**

# Hydrogen Safety Concerns In the Sulphuric Acid Industry

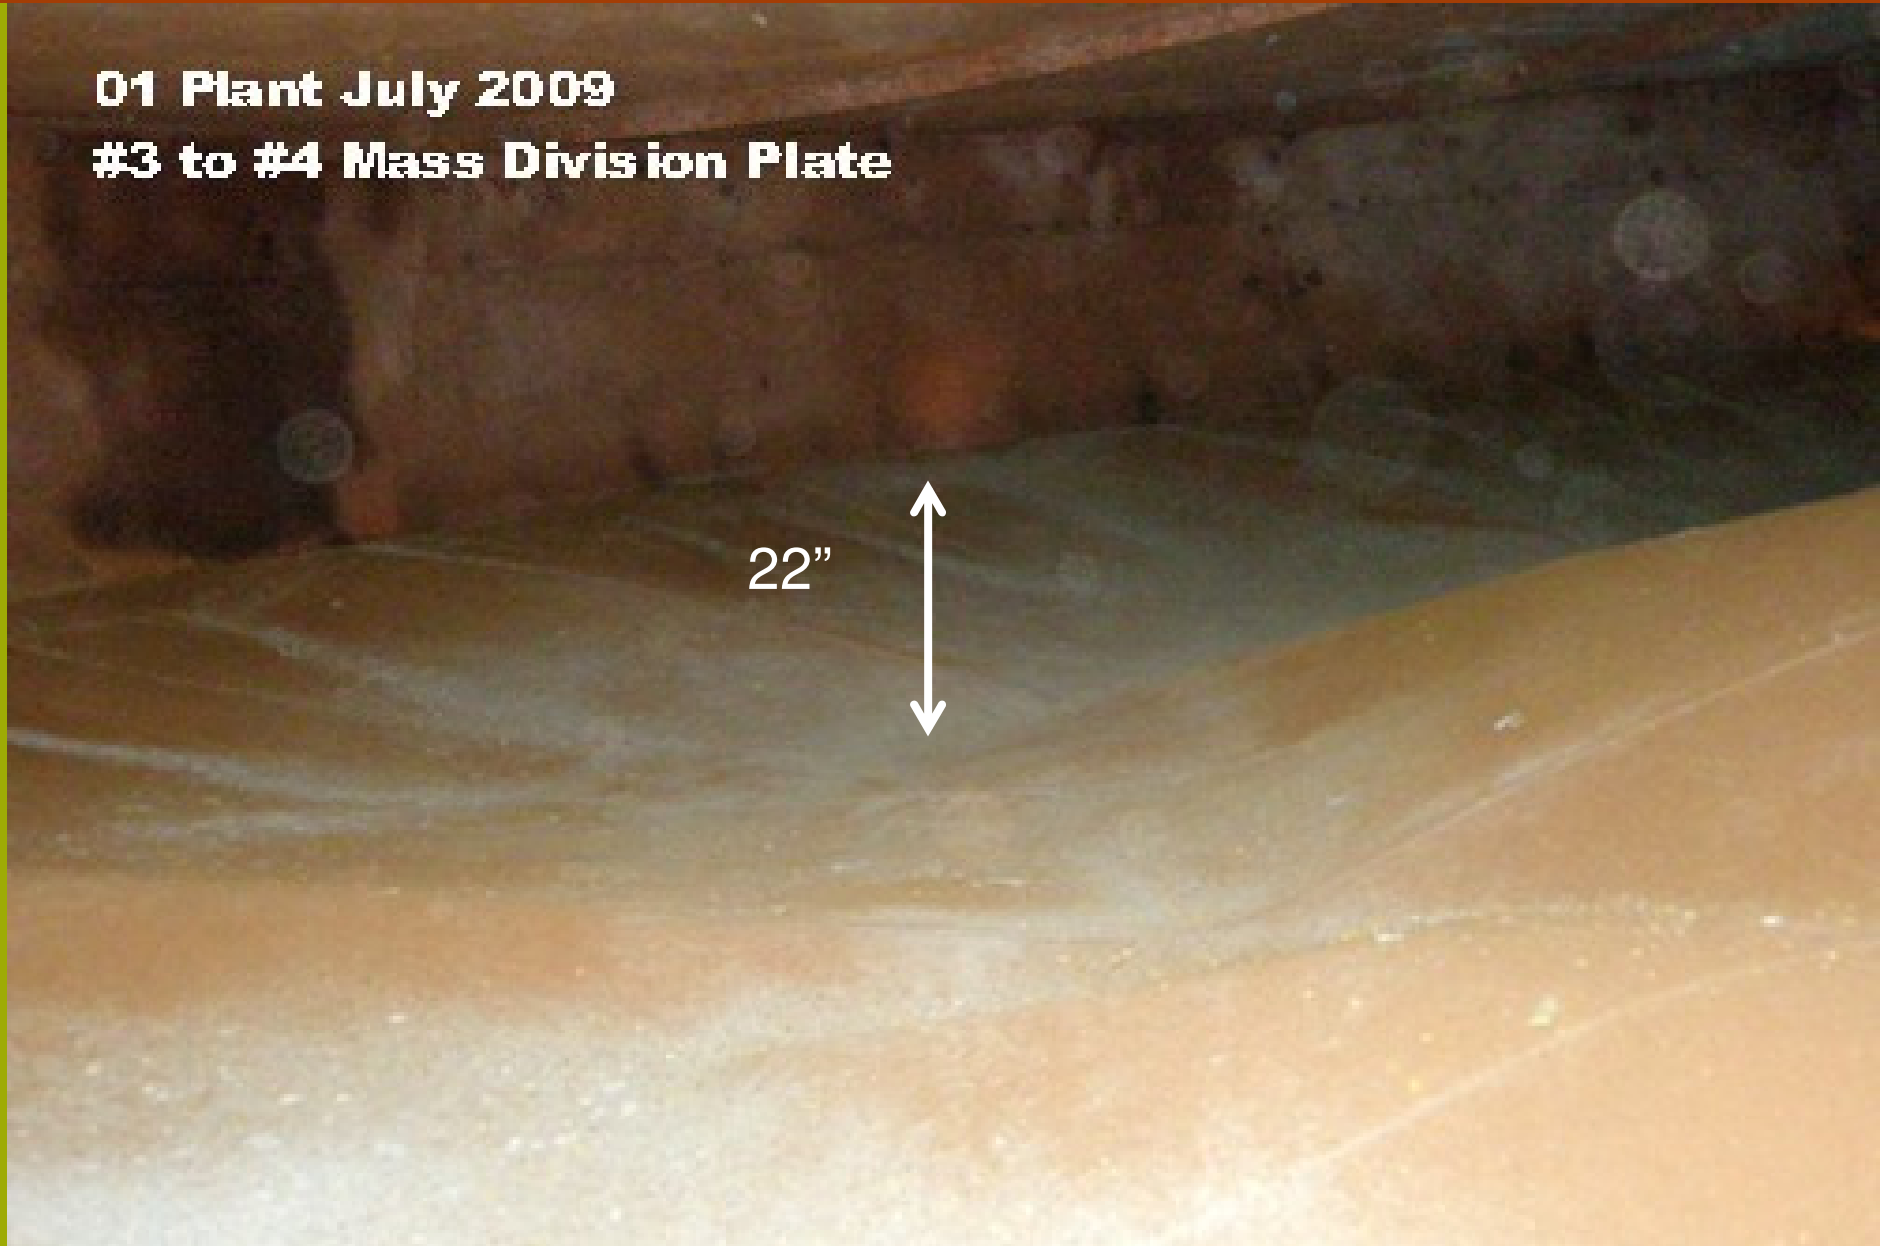
**#3 to #4 Mass Division Plate**

# First Failure – Radial Flow Converter Damage

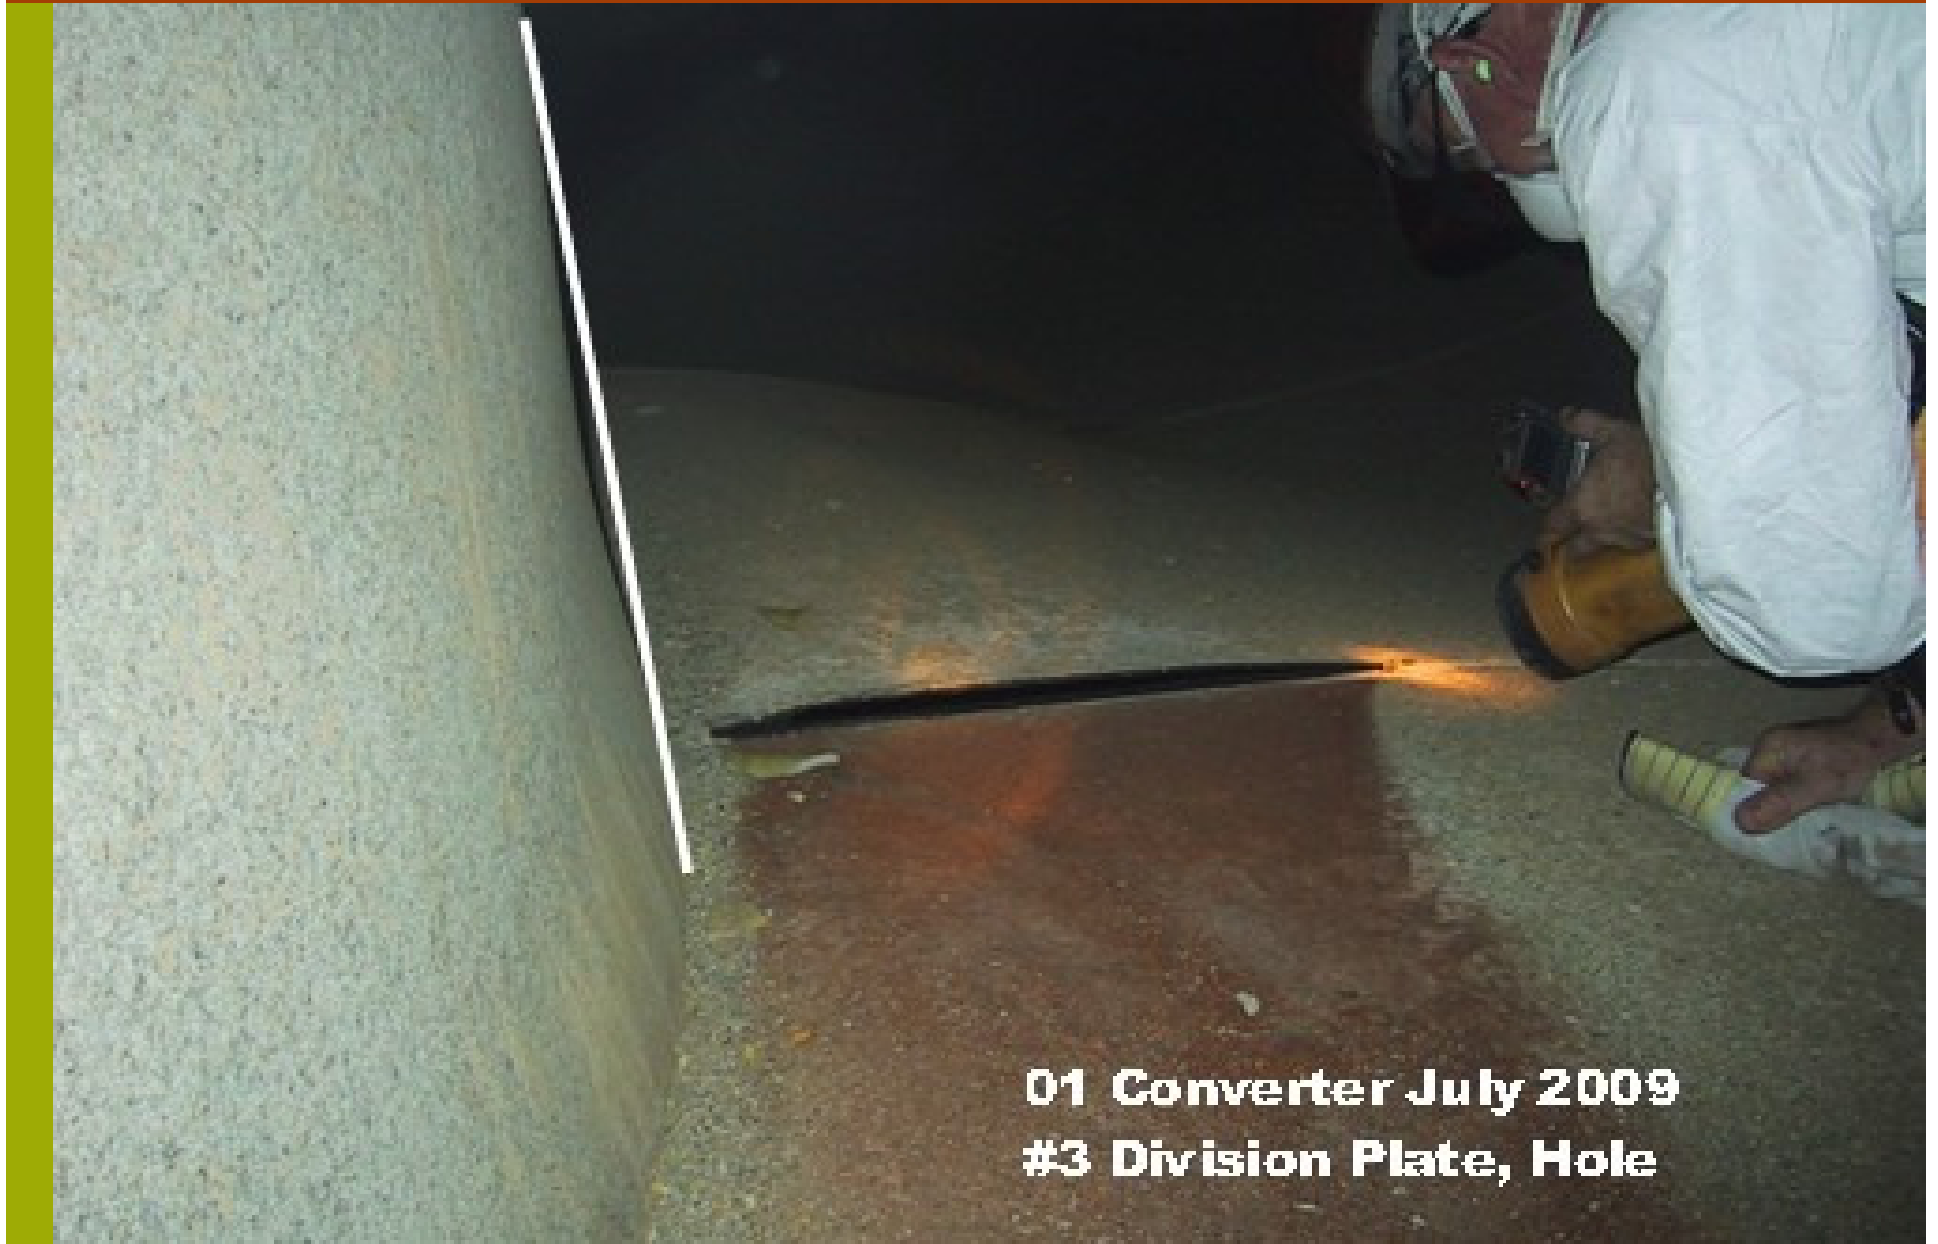
**01 Converter July 2009**  
**#3 Division Plate, Hole**

# Hydrogen Safety Concerns – First Failure

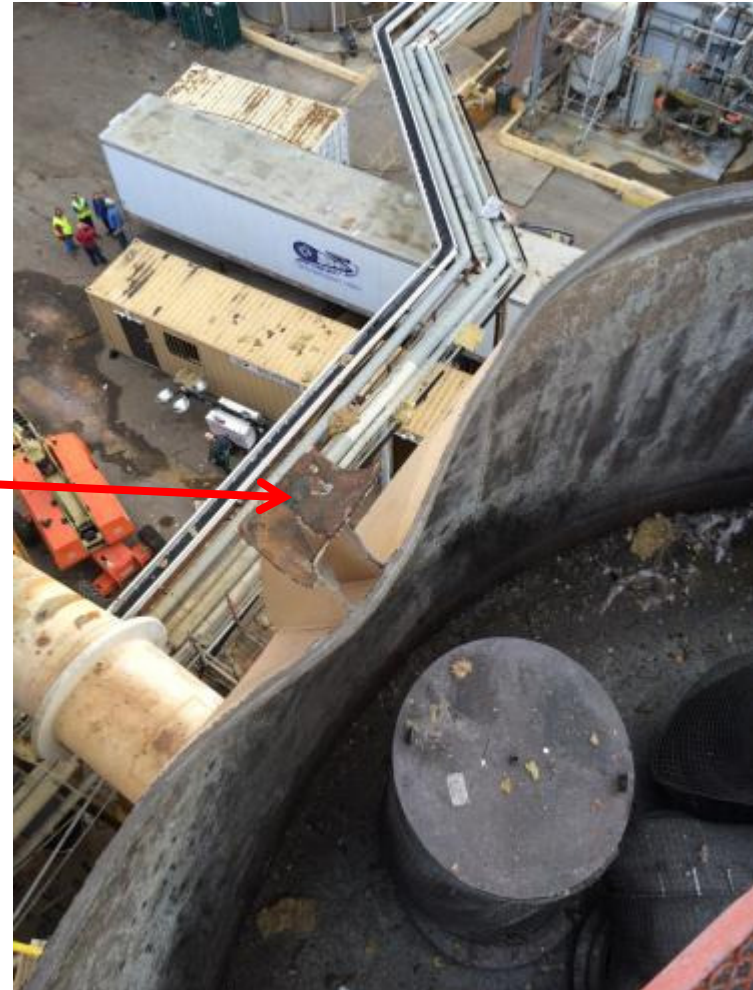
These two pictures show the IPA Exit Duct Support; where it used to be, where it wound up

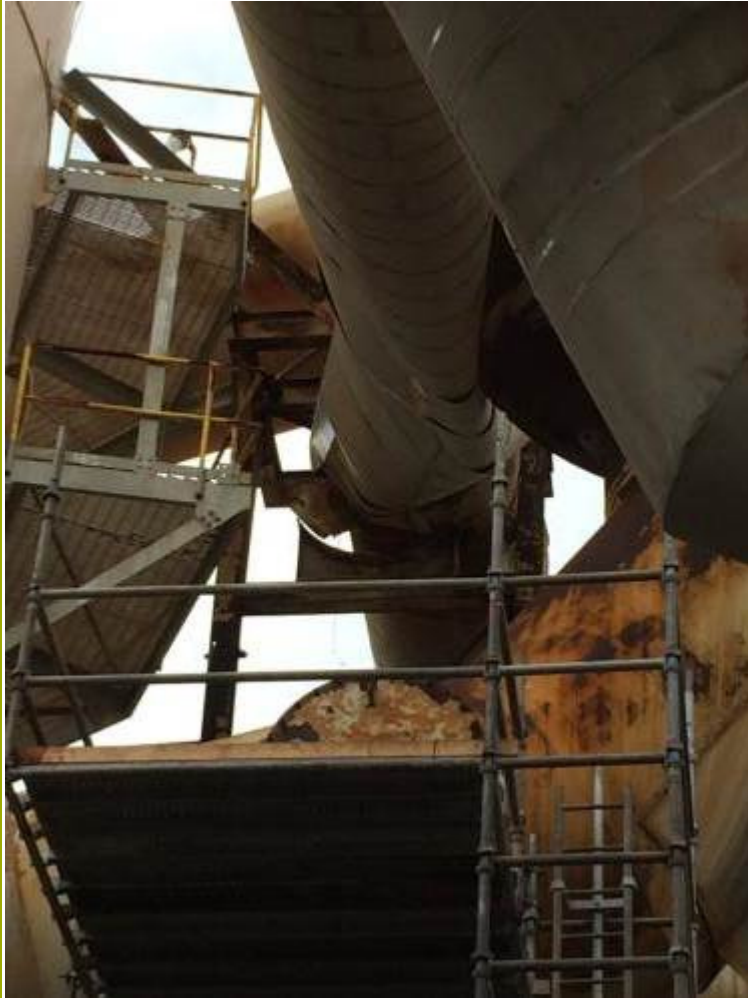
This is two pictures of the same section of duct. One from above and one from below

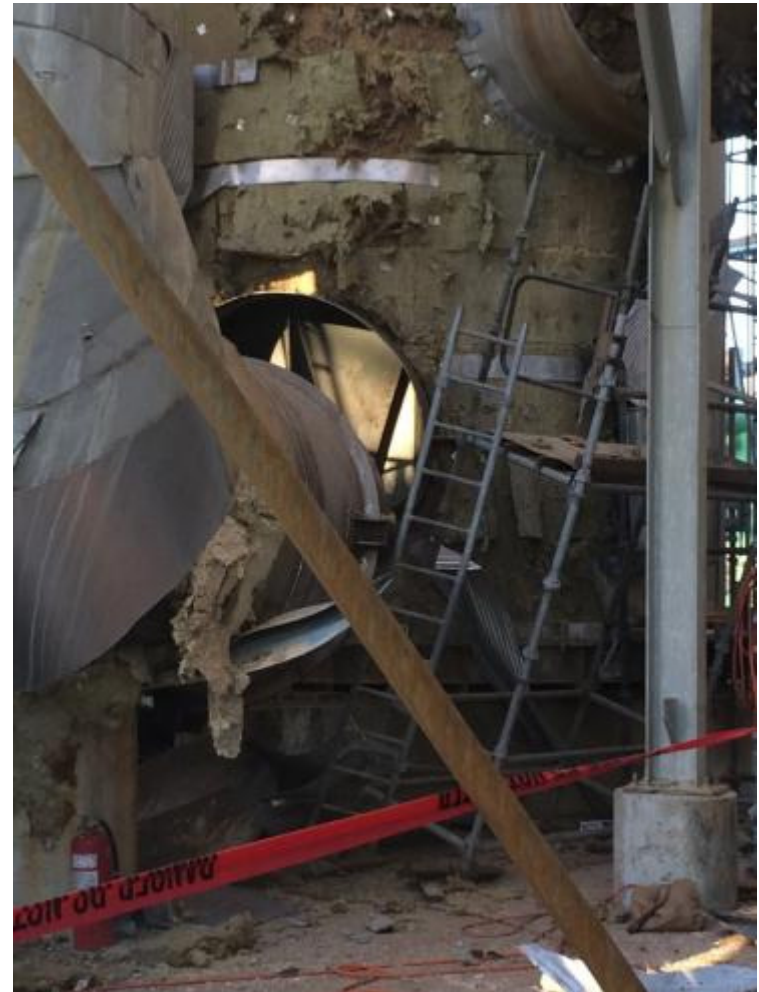
Left Picture shows where the contractor was actively welding the band on the duct  
Right picture shows the force of the blast blowing the flashing off the Cold Hex
