Chevron in primary scrubber vessel

Flame on!

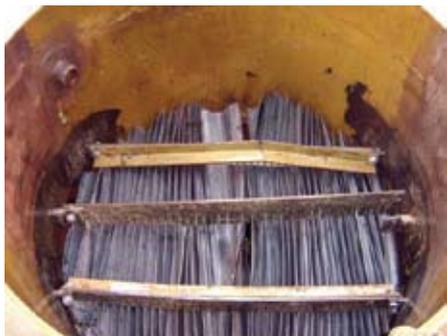
In this example, a high adiabatic saturation temperature in the scrubber caused the thin vanes to warp, which were not designed to withstand the gas temperature above 80 degrees Celsius (C). As shown below, the warping and dust accumulation

Chevron warping

on the blades created an open section in the middle of the chevron demister, resulting in improper gas distribution and increased gas velocity through remaining clean areas.

Proper maintenance and material of construction are critical in specifying chevrons. Plants need to be diligent in 1)

making sure operating temperature is compatible with materials, and 2) maintaining the intermittent chevron wash spray to keep its surfaces clean.

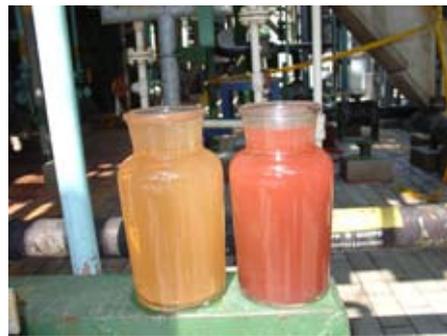
The chevron demister damage caused liquid carryover to enter the downstream equipment. The liquid carryover led to increased solids (iron content) in the downstream scrubber vessels (as shown in picture below), which can plug packed beds, foul equipments, and reduce overall scrubbing efficiency of the system. Fouling leads to reduced heat transfer, increased pressure drop, blocked ducts and pipes, and these effects are costly. The cost factors include increased fuel consumption, reduced throughput and increased maintenance.

Sample test from primary scrubber vessel
