# Difficult situations lead to lessons learned

By: Orlando Perez, OP & Associates-H<sub>2</sub>SO<sub>4</sub> Consultants

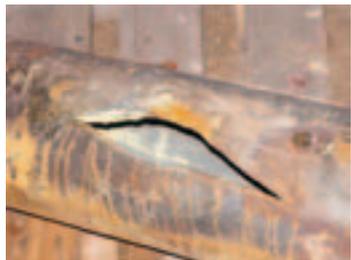
During one of the downtimes in this particular plant, the steam tracing encountered a problem and the molten sulfur that remained in the line froze. Steam tracing was eventually restored and thawing of the line started. After a few hours, a loud noise was heard and molten sulfur was seen spewing from a portion of the pipeline. What went wrong? The pipe experienced a thick-lip rupture as shown in Fig. 1. This rupture is indicative of over pressurization. Investigation revealed that only a section of the pipe was being thawed and the molten sulfur was blocked in. The inability of molten sulfur to thermally expand created over pressurization of the pipeline.

Fig. 1: Thick-lip rupture of 8" sulfur pipe.

Always start thawing frozen sulfur lines from one end to the other to allow free thermal expansion of molten sulfur. Procedures must be set in place and heat tracing must be designed to allow this.

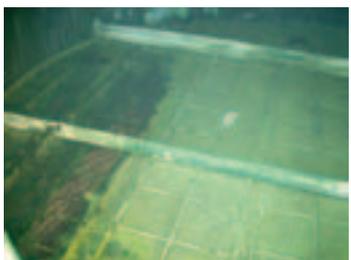
Fig. 2: Drying tower mesh pad corrosion due to loss of absorption efficiency.

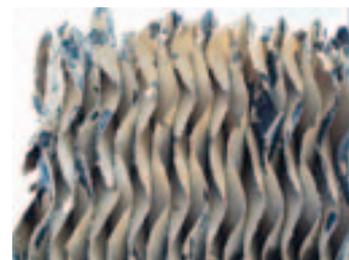
Fig. 4: Fouled top section of heat transfer fill.

when new. During turnarounds, work is mostly focused on cleaning the basin, but inspections to check for structural integrity are not normally scheduled. Such is the case for an acid plant in North America. The heat transfer fills were ignored and no inspection was performed for many years. It was only when the water outlet temperature crept up to 10 degrees that Operations was prompted to schedule an inspection. It was found that the heat transfer fill was almost plugged up with silt at the bottom section, as shown in Fig. 3. The top section was fouled but not clogged as shown in Fig. 4. Clogged heat transfer fills add load to the supporting structure. In this particular case, the increased weight of the fill was found to be six times the original installed weight. Luckily, the supporting structure did not collapse.

Heat transfer fills can easily get fouled, especially when water chemistry is not under control, and can easily get clogged in dusty environments. Deposits can add a few hundred pounds to the heat transfer fill's own weight.

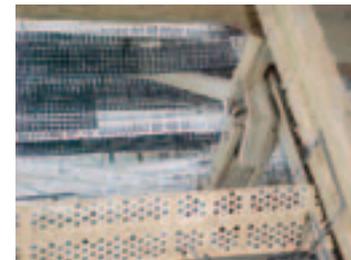
Fig. 5: Broken wooden column inside a cooling tower

In another North American acid plant, a worker who was climbing down the stairs of a cooling tower broke one of the treads and sprained an ankle. This prompted inspection of the cooling tower's structural components. The inspection revealed that the wooden components had deteriorated so badly that even some of the posts inside the cooling tower were broken, as shown in Fig. 5. Corrosion was so bad that the cooling tower was at critical risk of collapsing. Emergency measures were set in place to stabilize and prevent the tower from collapsing under high wind conditions.

Cooling towers require regular inspections for corrosion, fouling, and mechanical/structural integrity of their components, just like any equipment in direct contact with acid, SO<sub>2</sub> or SO<sub>3</sub>.
