Case histories from the sulfuric acid industry

By: Orlando Perez, H₂SO₄ Consultants

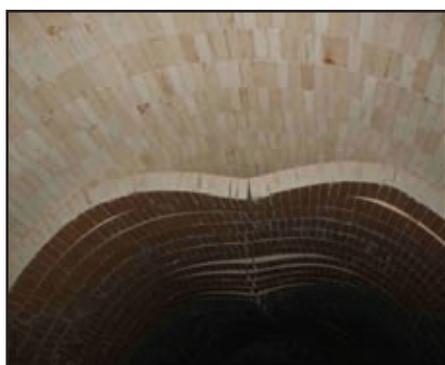
Fig. 1: Hot face layer subsidence

When selecting refractory materials, do not rely just on maximum service temperature data. Also consider the proper steel shell temperature, the atmosphere in which the refractory operates, and the volume stability of the hot face layer. Not considering these factors could lead to the refractory failures shown in Figures 1 and 2.

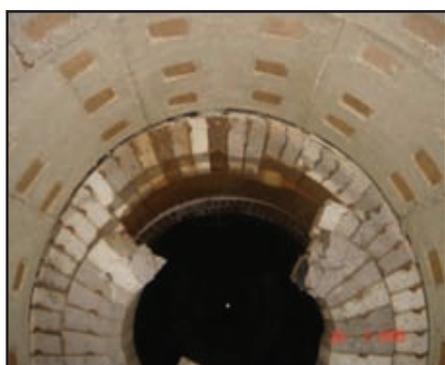
Fig. 2: Furnace choke ring failure due to refractory subsidence

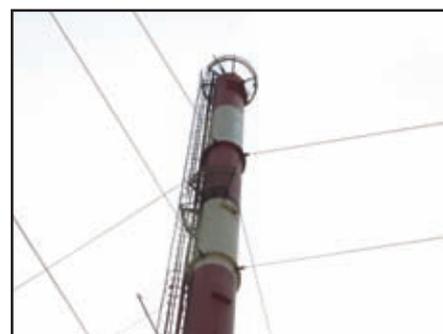
Plant stacks are designed as self-supporting, all-welded steel structures. They are equipped with a tuned mass damper near the top (Fig. 3) or with guy wires (Fig. 4) to minimize movements from high winds or seismic loads. Because of their height, they are usually fabricated in manageable sections, so they can be shipped to the site for assembly. To speed up the erection process, one designer had a

Fig. 4: Guyed stack

Like any acid plant equipment, inspection and maintenance of the stack is necessary for trouble-free operation. Bolts have to be inspected and replaced as required; guy wires have to be lubricated every three years and inspected with an electromagnetic flux sensor for discontinuities.
