Hydrogen safety in the sulfuric acid industry

By: James W. Dougherty, Process Engineer, Mosaic Fertilizer LLC

ACID PLANT EQUIPMENT FAILURES

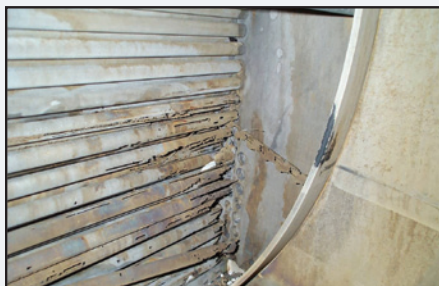
Acid cooler tube failures

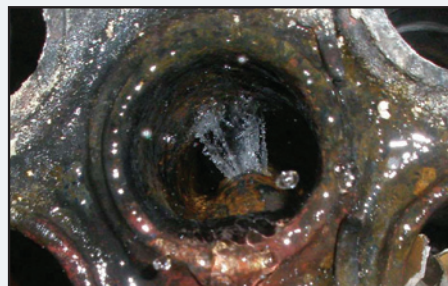
Waste heat boiler tube failure

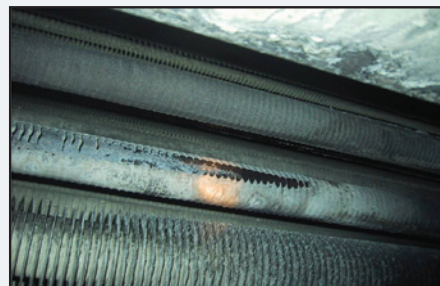
Economizer tube failure

The first incident was initiated by a severe economizer tube failure that produced weak acid concentrations in the range of 85 percent. The resulting hydrogen explosion occurred in a high point of the ductwork for an internal hot pass heat exchanger of a radial flow converter design approximately 1-hour and 20-minutes after emergency plant shutdown. No ignition source was ever identified, but the operating temperature in the area of the converter (Catalyst Bed #2 Outlet) where the internal duct that the hydrogen is suspected to have accumulated is reasonably close to the auto-ignition temperature of hydrogen gas.

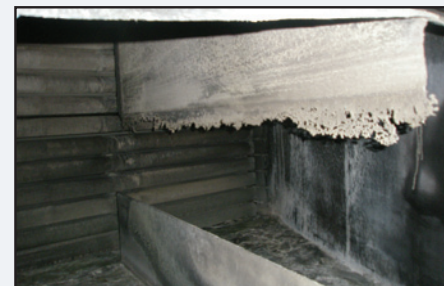
Severe baffle plate weak acid corrosion damage

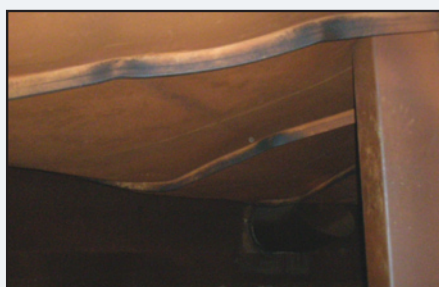
Converter division plate damage viewed from below

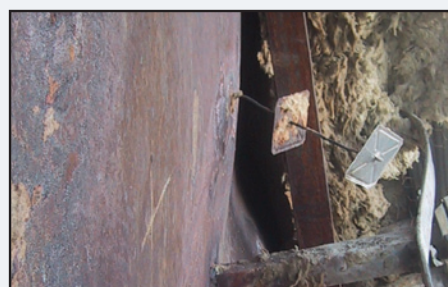
Converter shell damage – 4" circumferential buckling

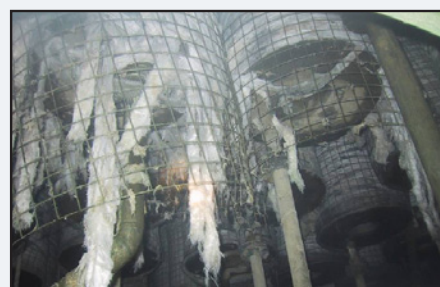
IPA tower mist eliminator candle damage

tower design and the other an alloy heat recovery acid tower design. Process gas temperatures present in the tops of acid towers are well below the known auto-ignition temperature of hydrogen so the ignition source in these cases is hypothesized to be a static charge buildup occurring in the non-conductive fiberglass bed of the acid mist eliminators. It is also notable that although the acid concentration (97.5 percent) in one of the tower incidents was nowhere near as weak as during the first incident, the accumulation of hydrogen gas reached explosive concentrations in approximately half the time. This may in part be interpreted as an indication that the higher acid temperatures and larger exposed metal surface areas are present in the heat recovery system tower resulted in a higher rate of hydrogen gas generation than during the incident involving the traditional IPA tower design.

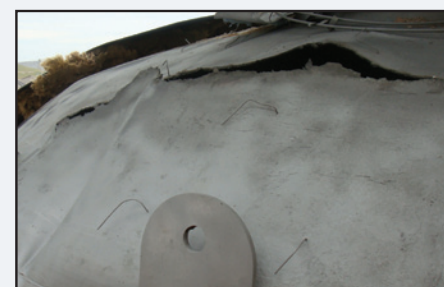
Heat Recovery System acid tower dome damage

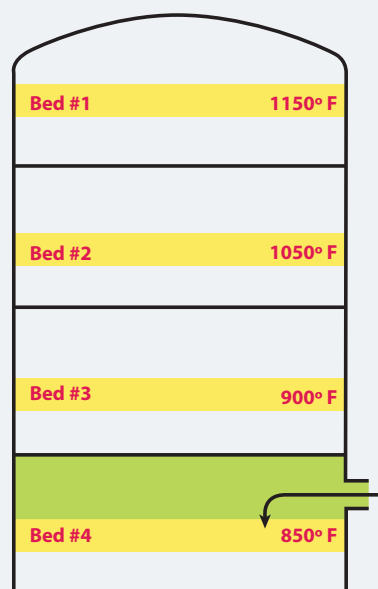
Fig.1:

TRADITIONAL CONVERTER: Hydrogen (green) enters converter contacting Bed #4 catalyst and chemically oxidizes.

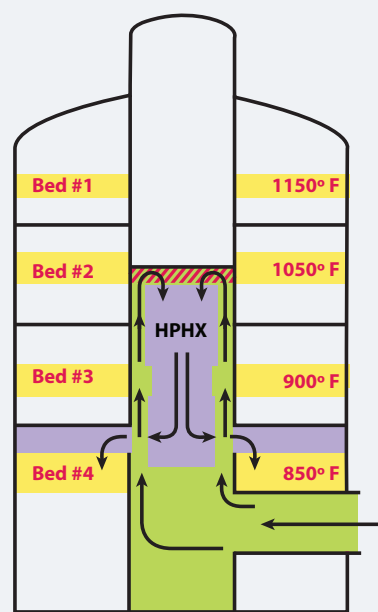
RADIAL FLOW CONVERTER w/INTERNAL HPX: Hydrogen (green) enters and collects in top of internal duct (red) before it can flow back down through HPX (purple) and contact Bed #4 catalyst.
