## LESSONS LEARNED

# Case histories from the sulfuric acid industry

By: Orlando Perez, OP & Associates Ltd. – H<sub>2</sub>SO<sub>4</sub> Consultants

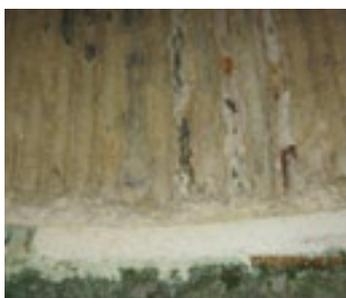
The sulfate blockage is normally the symptom of poor equipment design, improper operation and/or non-maintenance of the pieces of equipment upstream. Fig. 1 shows sulfate blockage in the shell side of a cold reheat exchanger with stainless steel tubes. The SO<sub>2</sub> gas passages are almost entirely blocked. Fig. 2 shows sulfate blockage in the tube side of a cold reheat exchanger. The inner 10 rows of tubes are

Fig. 1: Sulfate blockage on shell side.

Do not put the cart before the horse! Correct the root cause of the problem first before replacing the exchanger. Replacement designs should be given due diligence by an independent consultant who has knowledge and experience in the operation and maintenance of the equipment.

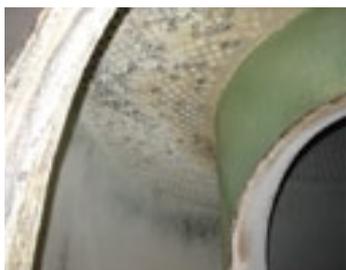
Fig. 2: Sulfate blockage on tube side.

blocked for SO<sub>3</sub> gas passage.

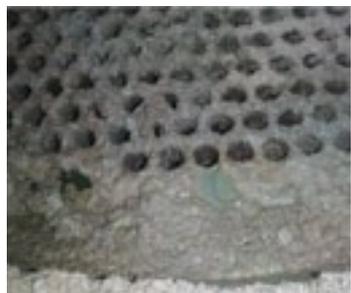
To solve the blockage problem, some plants choose to correct the symptom rather than address the root cause. The exchanger is replaced with some modifications when all the sulfate removal techniques in their arsenal have been exhausted. Reversing the SO<sub>3</sub> flow from the traditional downward flow inside tubes and changing the material of construction to stainless steel are some of the techniques used. All these have proved to be inadequate and after less than three years in operation, the plant is back to square one. Cases in point are shown in Fig. 3 where SO<sub>2</sub> gas was switched with the traditional upward flow in the shell side to downward flow inside the tubes, and in Fig. 4 where SO<sub>3</sub> gas flow was reversed from the traditional downward flow inside the tubes to upward

Fig. 3: Cold exchanger with SO<sub>2</sub> flowing down inside tubes.

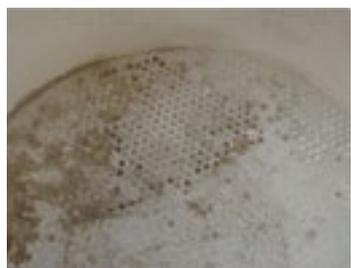
Fig. 4: Cold exchanger with SO<sub>3</sub> flowing up inside tubes.

flow inside the tubes. All these modifications were in vain.

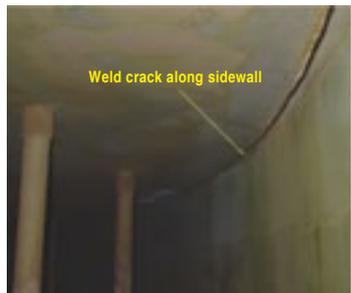
Fig. 5: Divider plate between beds 3 and 4.

Fig. 5 shows a photo of the divider plate between beds three and four. A portion of the circumferential weld on the sidewall cracked due to the high-pressure drop in the cold reheat exchanger.

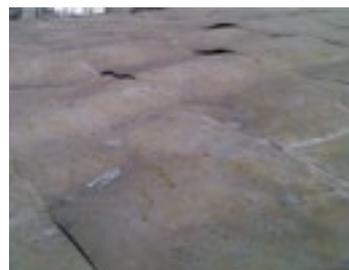
However, this is not always the case, as shown in Fig. 6 where the cladding on the roof of a converter has been badly deformed due to improper design, not accounting for the expansion/contraction of the cladding. In this particular case, the water that en-

Fig. 6: Cladding on roof of converter.

Never take for granted the cladding for thermal insulation of hot pieces of equipment, ducting and piping. Cladding, like any other acid plant equipment, should be given regular inspections. When damage is found, it should be repaired at the most opportune time. Design of the cladding should not rest entirely on

the insulation contractor. Someone with know-how and experience on how the equipment operates should review the design.

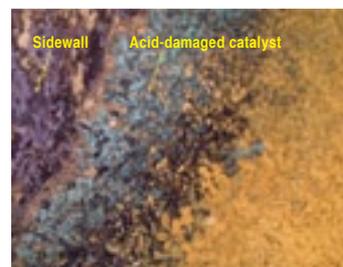
Fig. 7: Catalyst damage along sidewall perimeter.

tered through the gaps ran down the sidewall of the converter and cooled the metal, causing condensation of acid on the catalyst along the perimeter of the sidewall. Fig. 7 shows the catalyst damage caused by acid condensation.

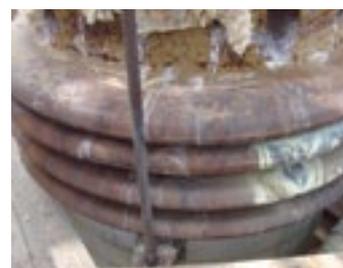
Fig. 8: Water ingress through the cladding of an expansion joint.

Fig. 8 shows evidence of water ingress through the cladding of an expansion joint due to inadequate flashing and sealing. The

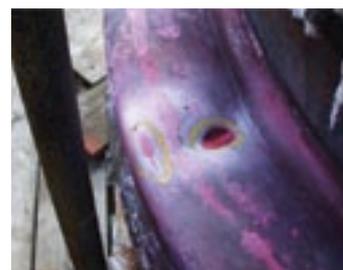
Fig. 9: Badly deformed and cracked expansion joint convolution.

sudden cooling of the hot metal badly deformed the convolution and created cracks in the metal, as shown in Fig. 9.

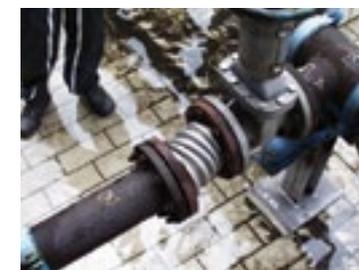
Fig. 10 shows an expansion joint for a product-acid piping that is incorrectly applied. Based on the inspection of the piping run and considering the operating temperature of the product acid, the need for an expansion joint is not required. This particular expansion joint, however, was installed to bridge the gap from misalignment caused by poor pipefitting. The expansion joint is permanently deformed and poses a safety hazard to everyone in the area.

Fig. 10: Expansion joint in a ductile iron piping system for product acid in the cold position.

Misapplication of expansion joints can have serious consequences to the health and safety of everyone in the area. Always

consult with a piping stress engineer for the proper type and application of expansion joints prior to installation.
