Hydrogen Incident December 2010

“To Learn and Share”

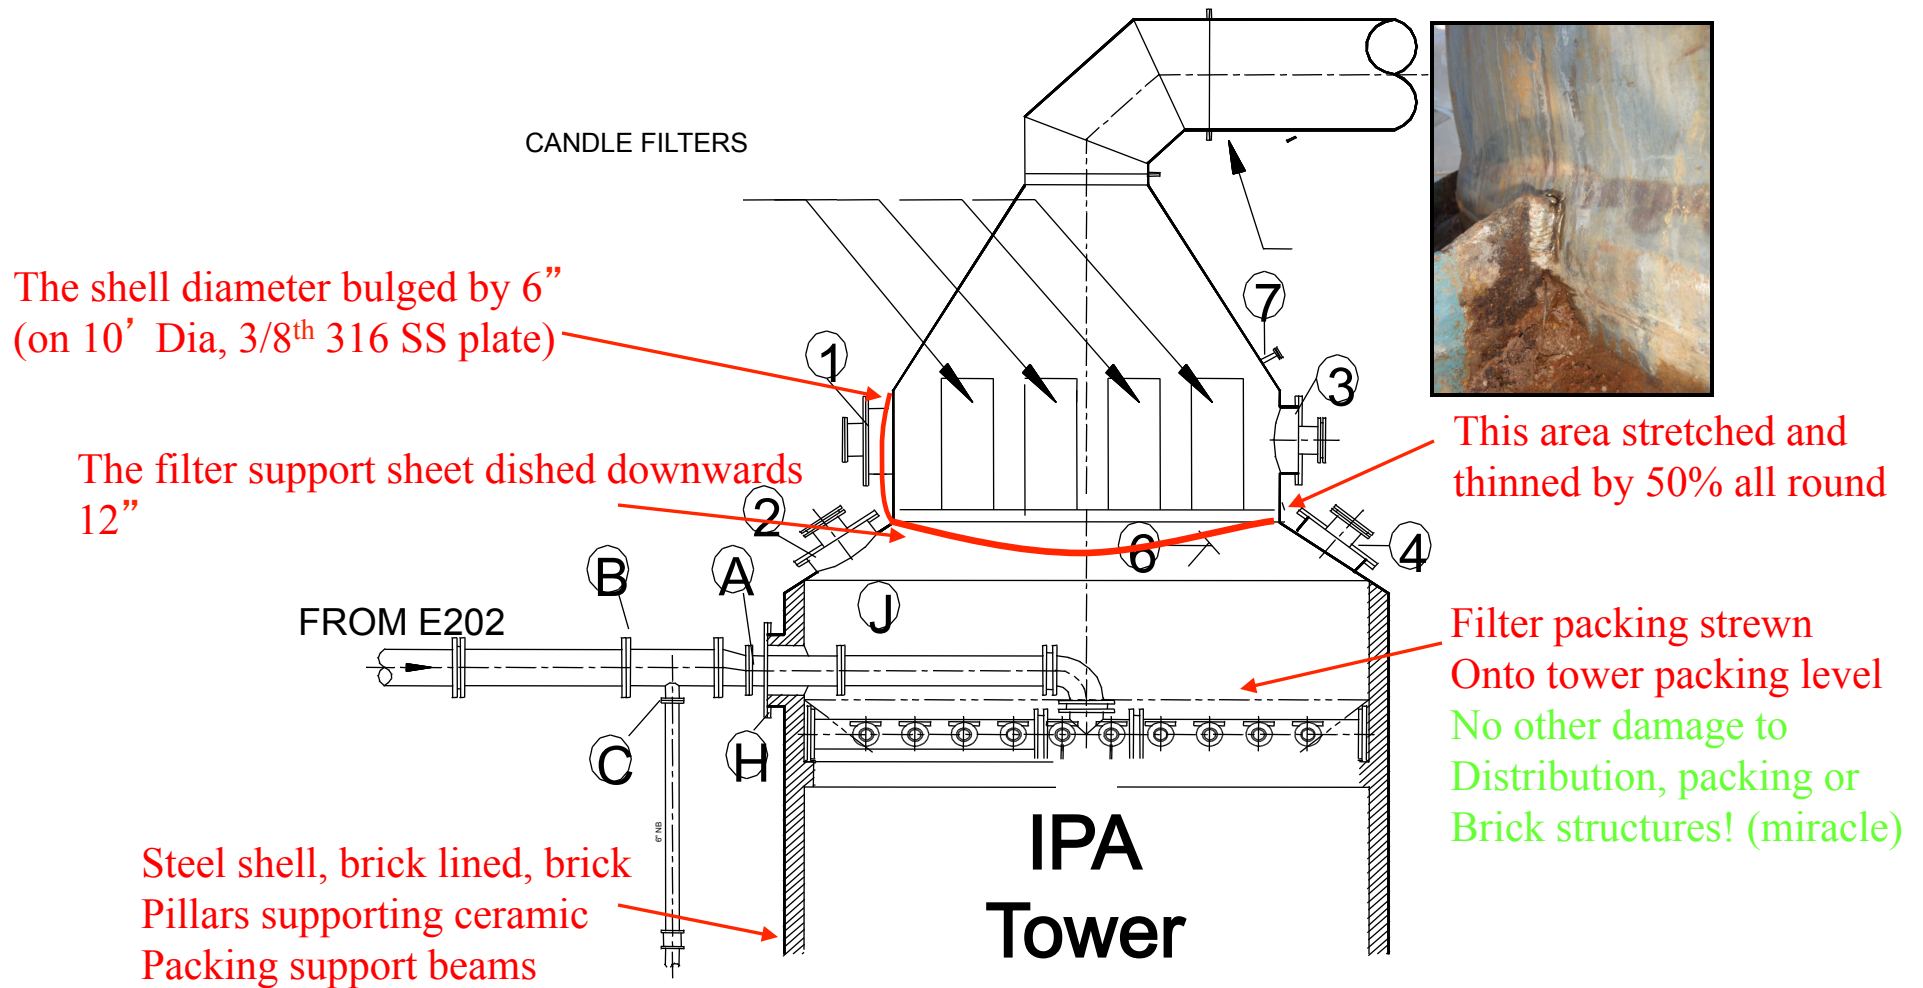
Taking the strain.....

- ▶ The pressure generated resulted in damage (deformation, bulging and cracks) to the top of inter-absorber tower and destruction of the candle filters in the tower
